Mini C-arm Protector

Singapore Healthcare Management (SHM) Conference 2021 – Shortlisted Project
(Operations Category)

The Shield that protects the Mini C-arm

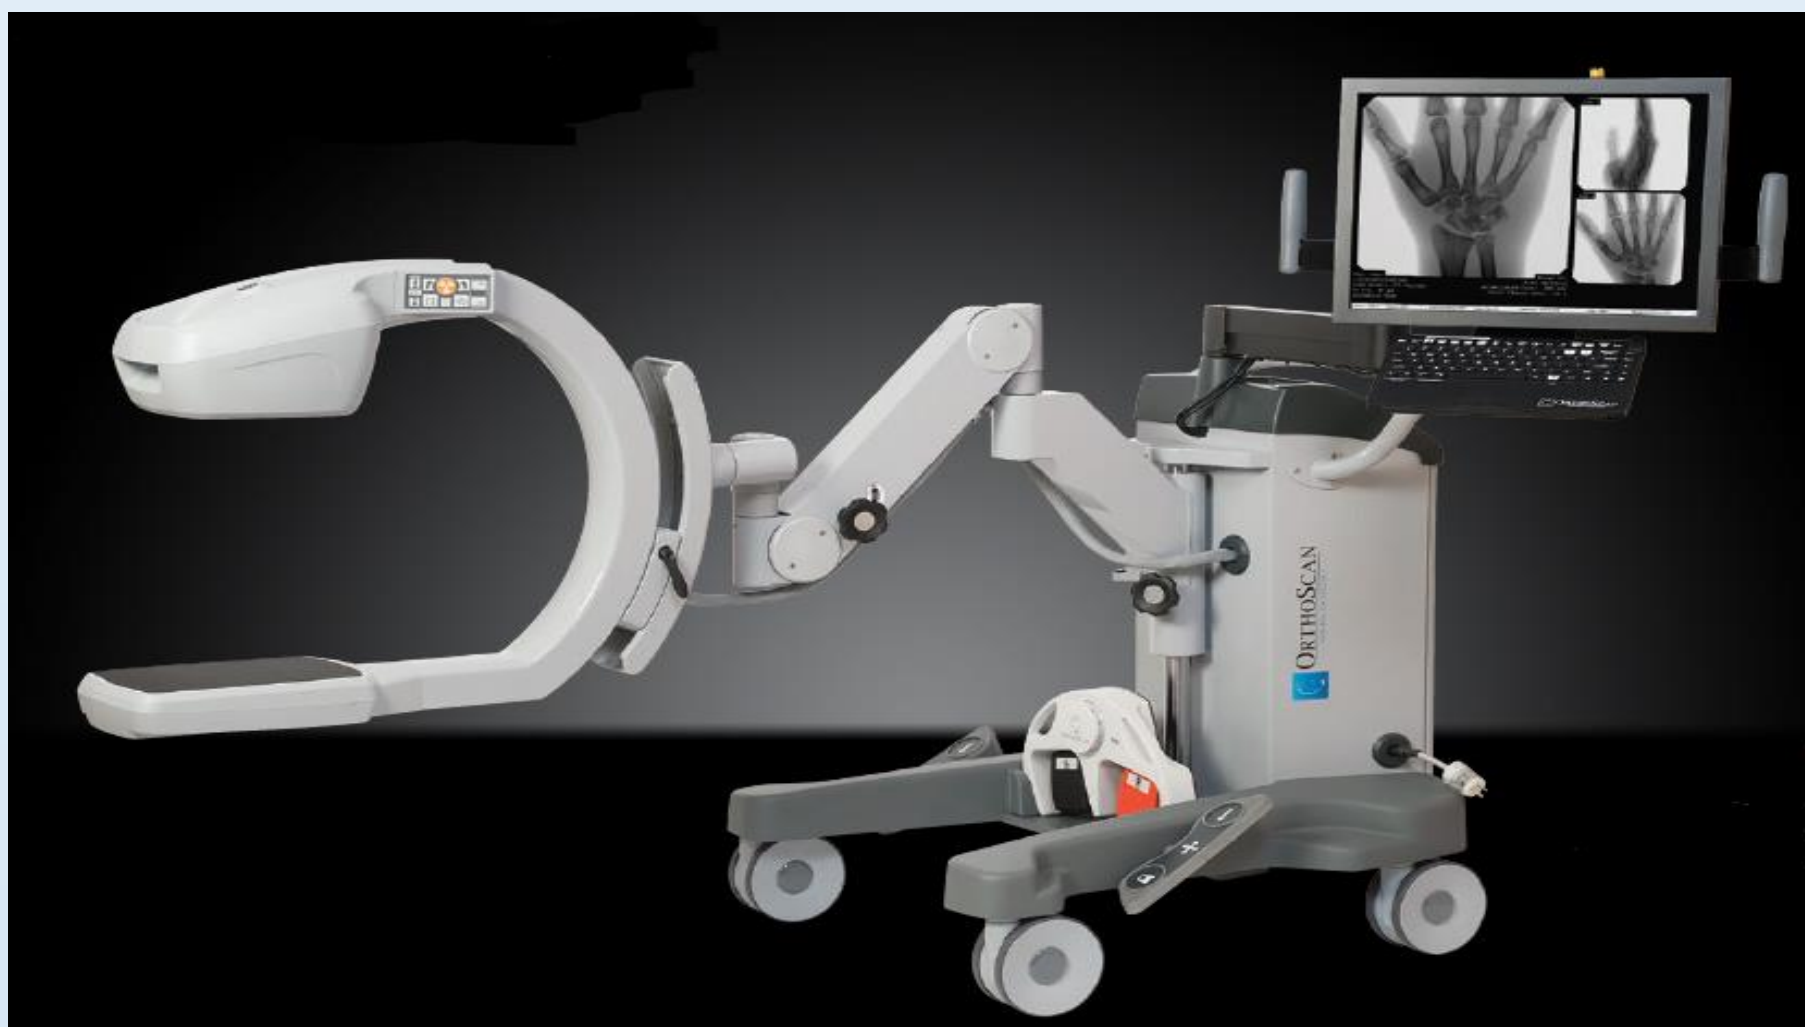
The Mini C-arm combines the components of a standard full-sized C-arm into a compact one-piece system designed especially for extremity orthopedic imaging. It is widely used in orthopedic surgeries especially in upper limb and foot/ankle surgeries.

Full view of Mini C-arm

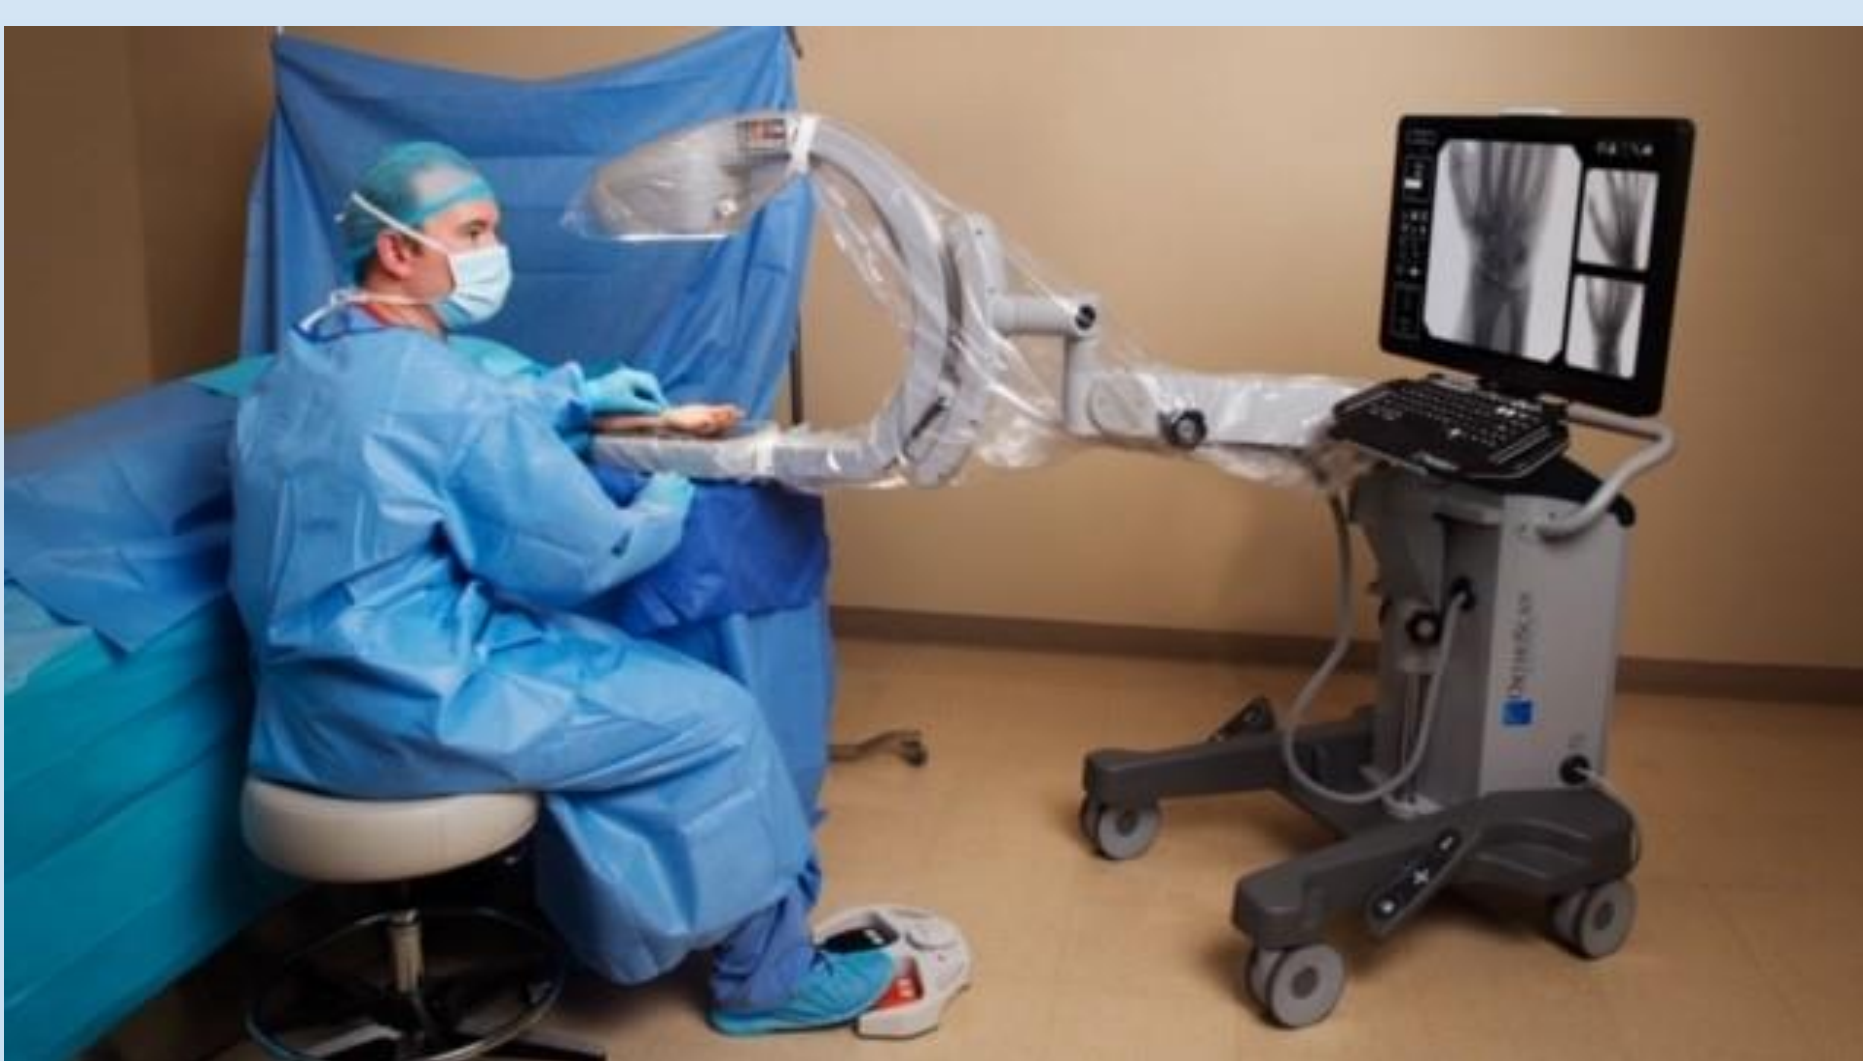
During the surgery, the surgeon places the operated limb on the flat detector of the Mini C-arm. The surgeon drills the limb under guidance from the imaging concurrently. However, at times, due to the size and the density of the bones, the drill bits may go thru the bones causing damages to the Mini C-arm drape or even the detector.

Upper limb surgery with Mini C-arm

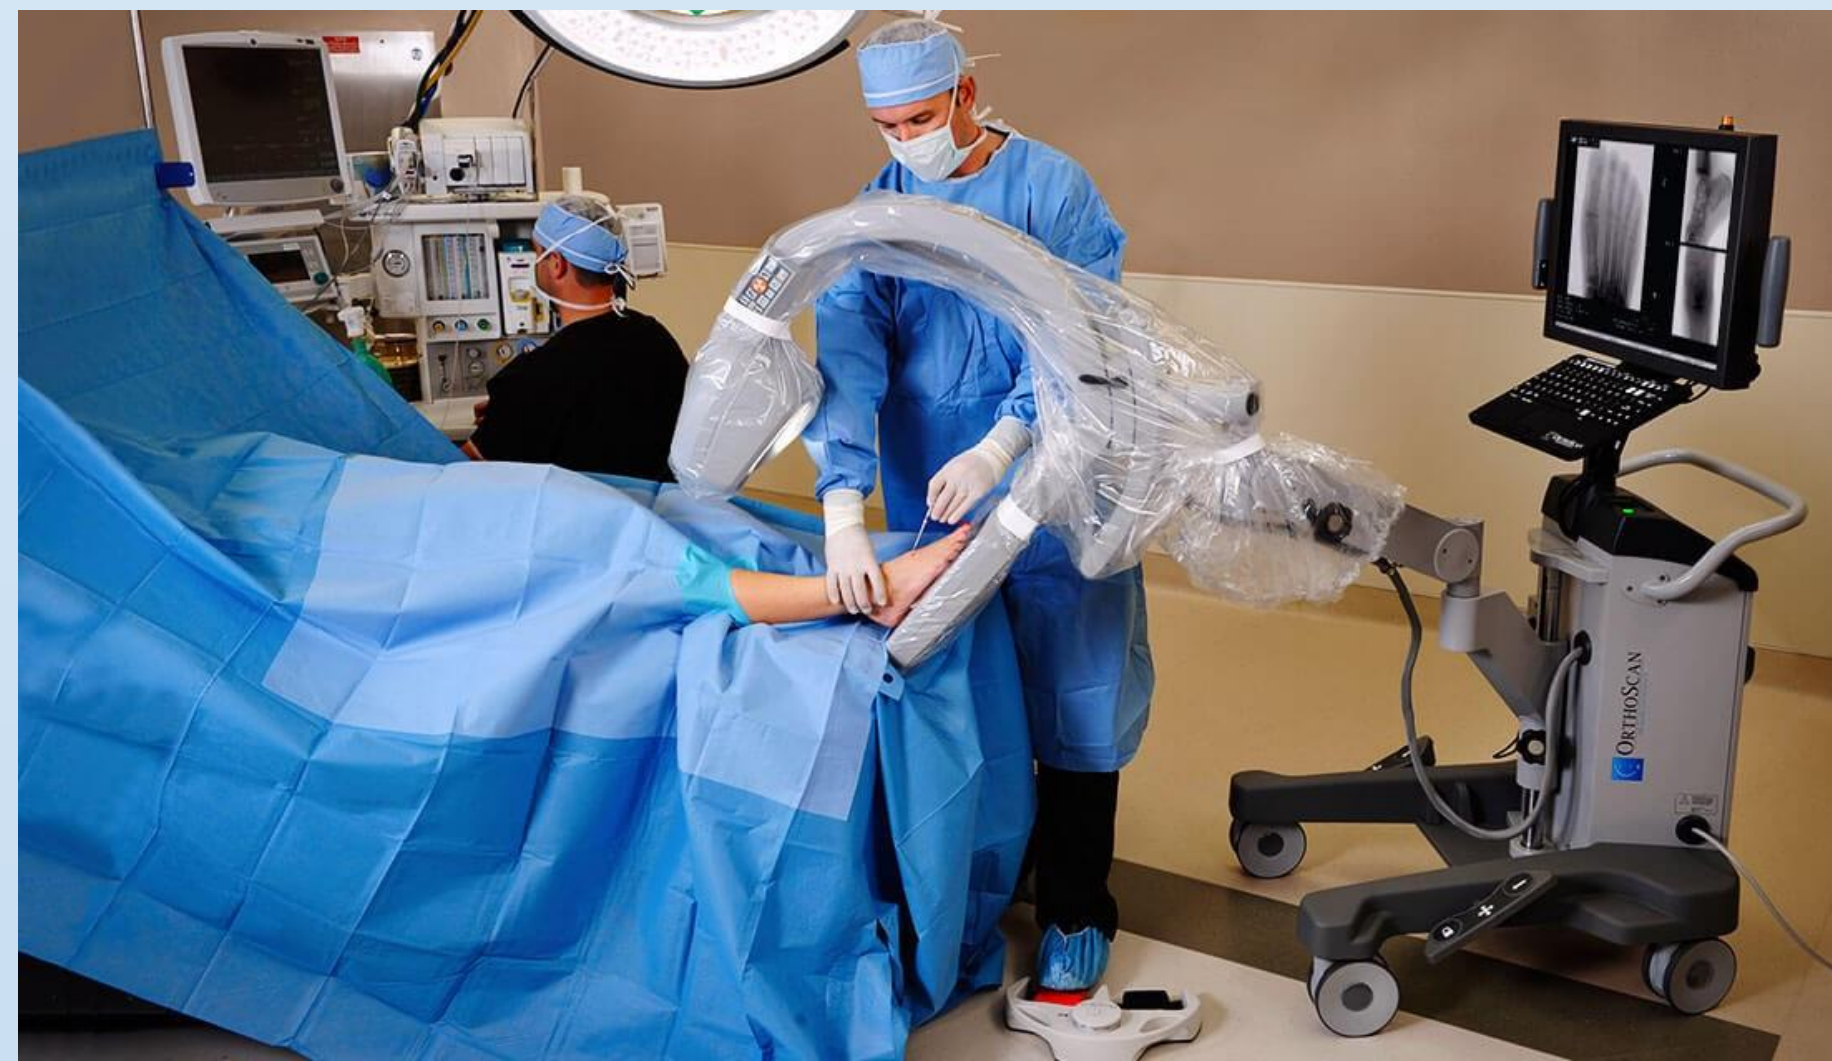
Lower limb surgery with Mini C-arm

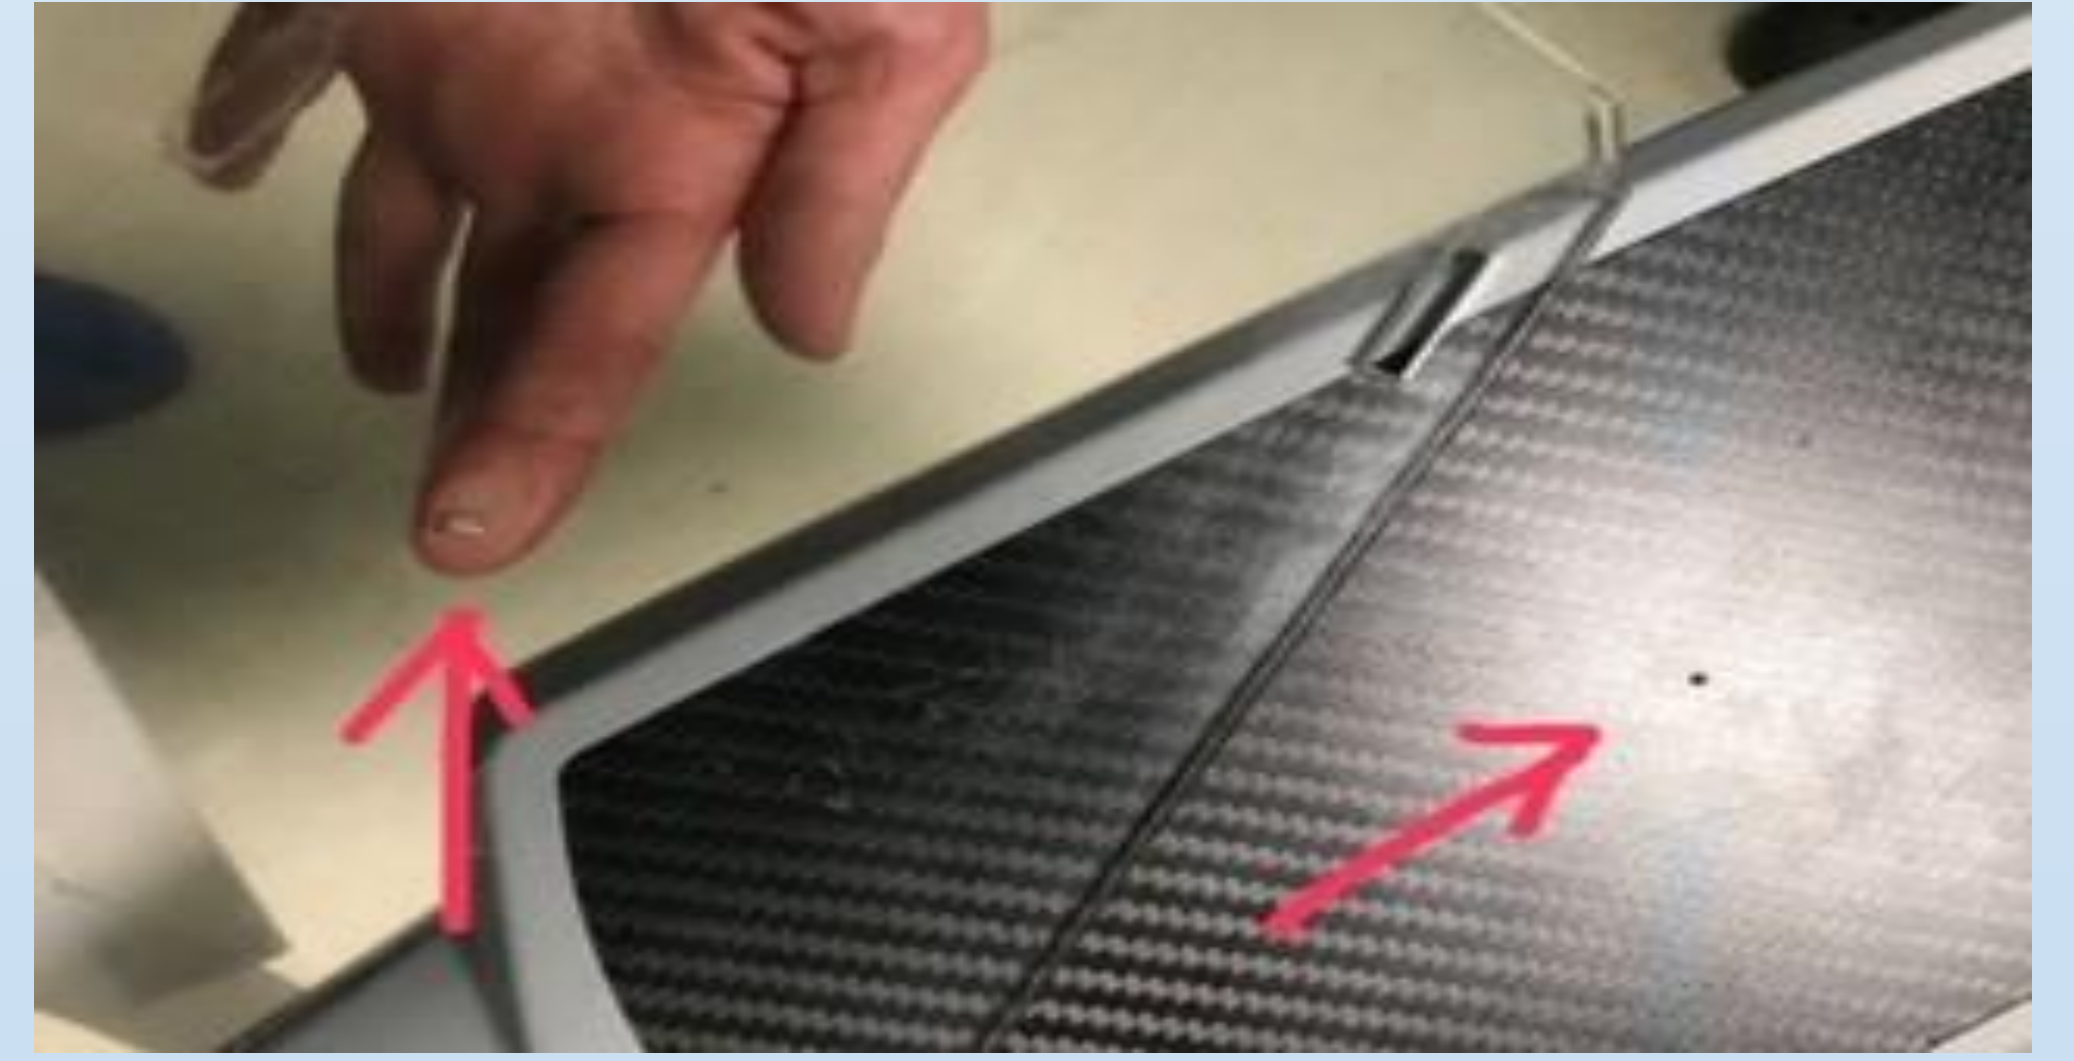
Holes on Mini C-arm detector and cover

- High repair cost
- Long downtime of the machine for replacement of damaged parts
- Delay in surgeries due to lack of machines

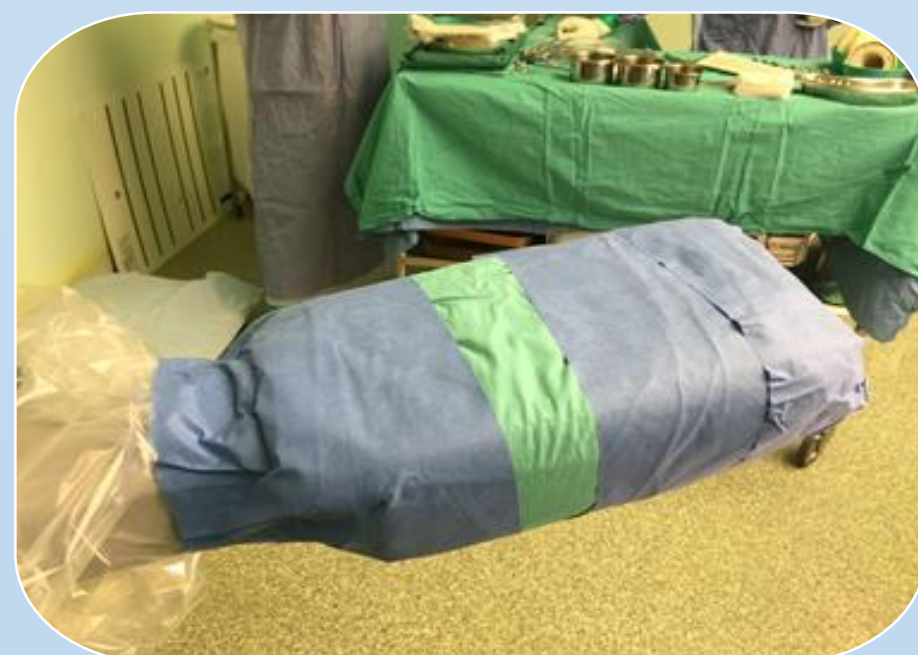
Using stack of linen to protect the flat detector

- Time consuming to secure and remove the stack of linen
- Drill/wires are sharp, they still penetrates through linen and causes damages to the detector
- Incident of penetration onto the flat detector (machine breakdown)

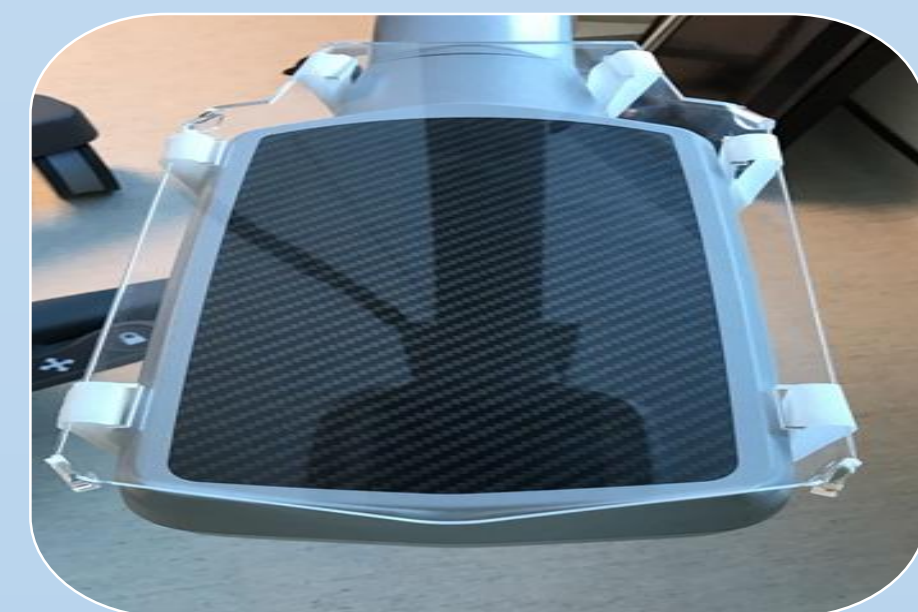
Custom made a single layer acrylic plastic protector

- More durable compared to stack of linen
- Likely chances of penetration onto the machine when not cautious (6 puncture holes found on the acrylic protector)

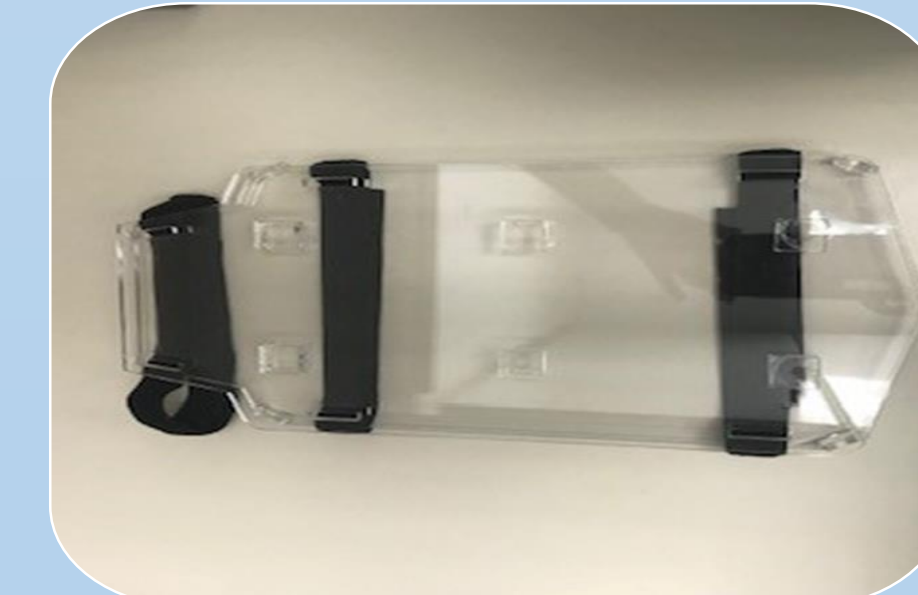
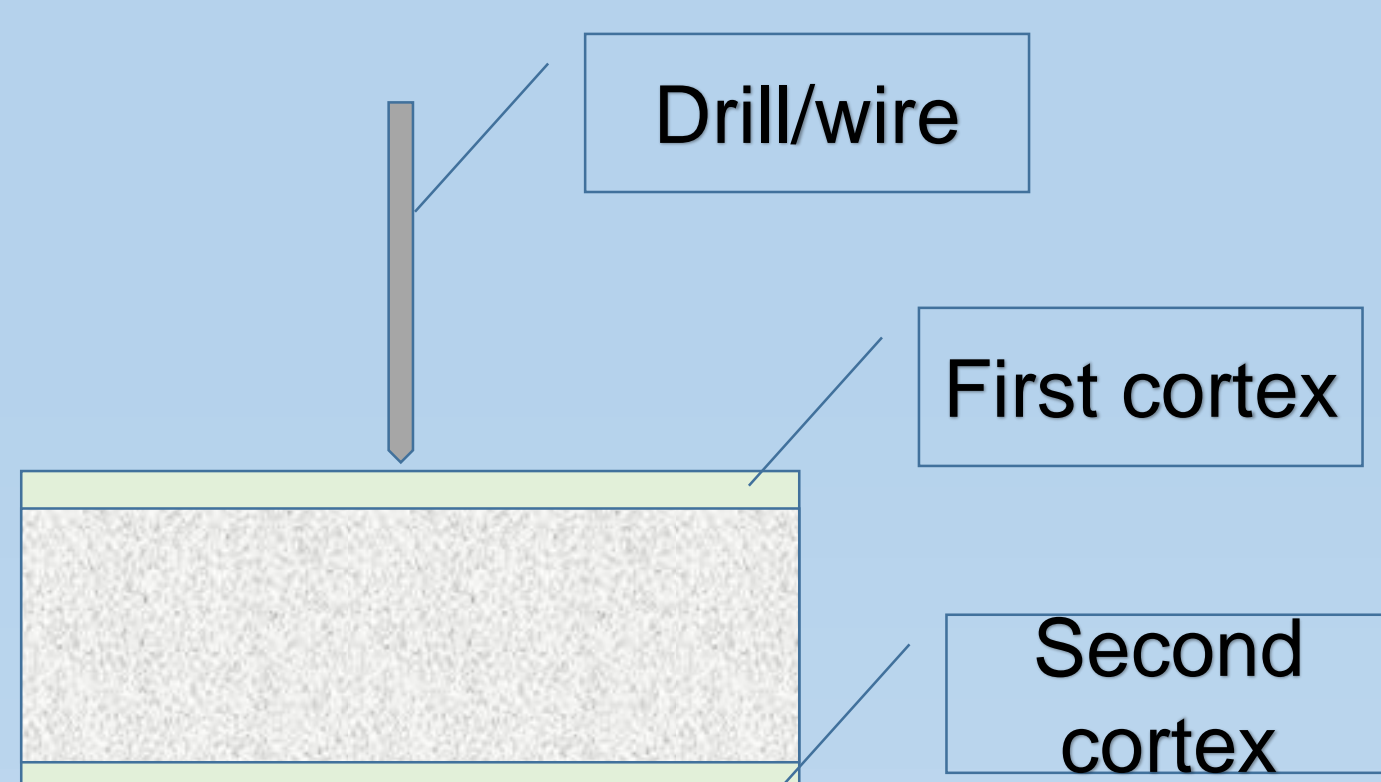
Custom made double layer acrylic plastic protector

- Double protections
- Eliminate chances of penetration onto the mini c-arm
- Removable for cleaning and maintenance of the machine
- Washable and safe to use disinfectant for infection control purpose

The idea of double layer acrylic protector was originated from the concept of dual cortex of the bone structure. The team brainstormed to customize protector for the mini c-arm. The design of the protector was enhanced through the PDSA cycle.
