To Design a Peripherally Inserted Central Catheter (PICC) Safeguard to Prevent Dislodgement of PICC

To Design a PICC Safeguard to Prevent Dislodgement of PICC Neo Soon Keow Qin Jing

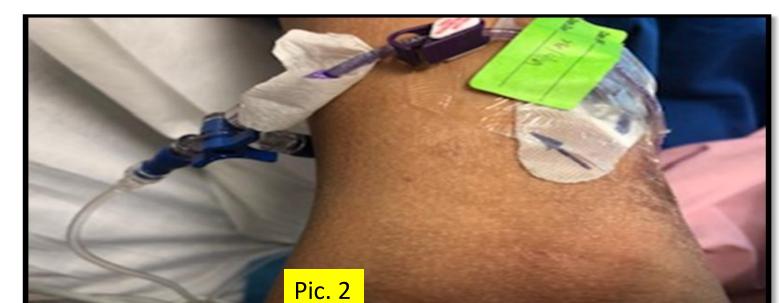
PICC dressed up with stat lock and transparent dressing

PICC External lines exposed and tangling without support potentially loosen PICC dressing and increase risk of dislodgement

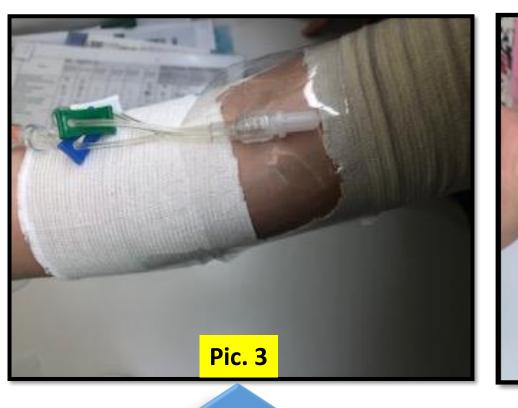
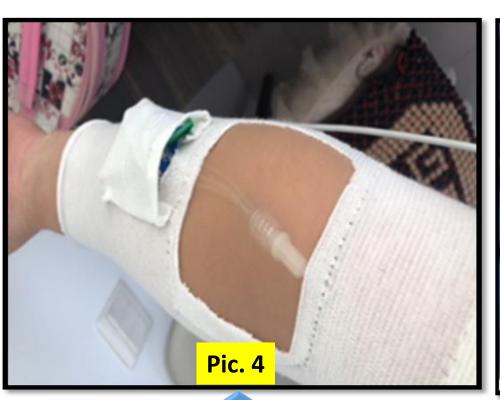
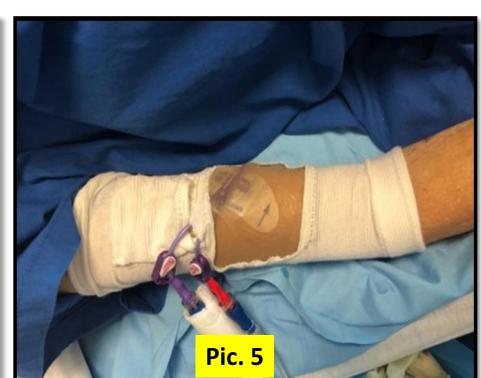
Plan-Do-Study-Act

PDSA Cycle 1
1st Prototype
created based
on root causes
identified on
3/2/2019

PDSA Cycle 2
Window
material
changed from
plastic to
stocking

Improve material elasticity based on feedback

5 PDSA cycles were conducted, and product redesign were done based on the trial feedback. Final Trial Version:

- The material is stretchable
- Good Securement
- Comfortable, not hot
- Visible at insertion site
- Fit to all arm PICC circumferences
 Fit for different directions of PICC insertion

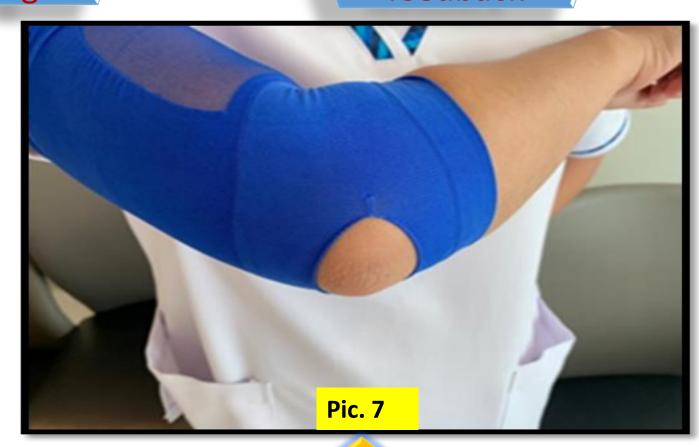
PDSA Cycle 4
Collaboration
with External
Vendor for
Mass
Production

PDSA Cycle 5
Create Opening
at elbow for
patient
comfort and
skin integrity
assessment
