Staircase to Safety

KK Women's and Children's Hospital

Singapore Healthcare Management (SHM) Conference 2018 – Shortlisted Project (Risk Management Category)

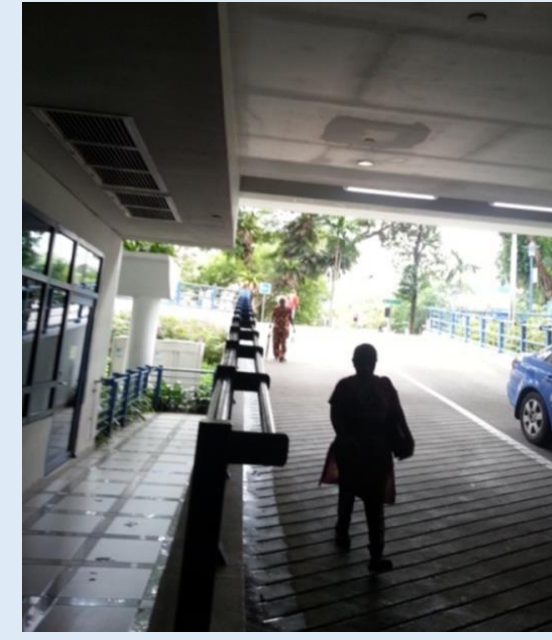
## 1. Introduction

Recurring slips and falls, especially during wet weather, on the vehicle ramp linking street level and basement 1 access at Women's Tower. There was no direct pedestrian access from street level to the basement 1.

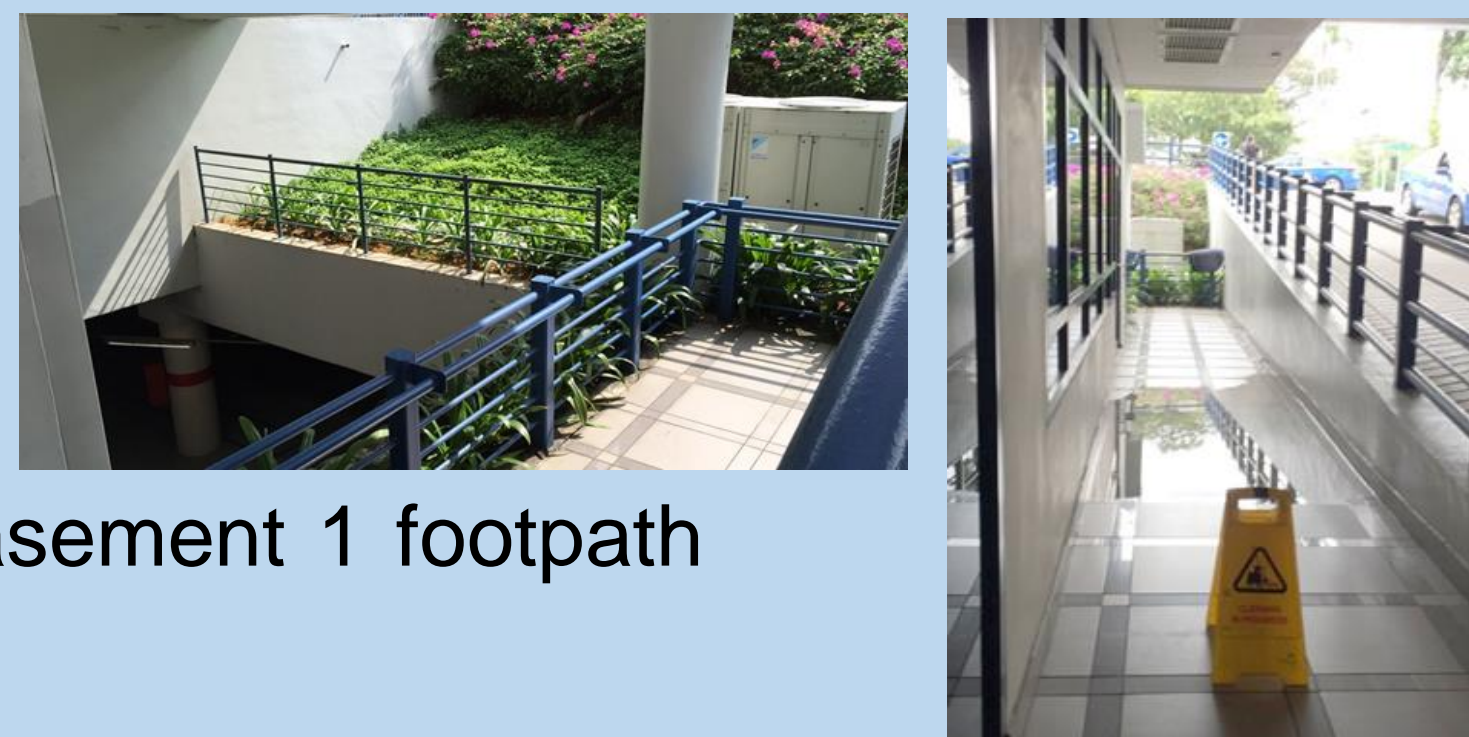
To eliminate recurring water-ponding at basement 1 footpath beside the vehicle ramp.

Surveyed the site and found that we could not safely fit a pedestrian ramp in the tight space.

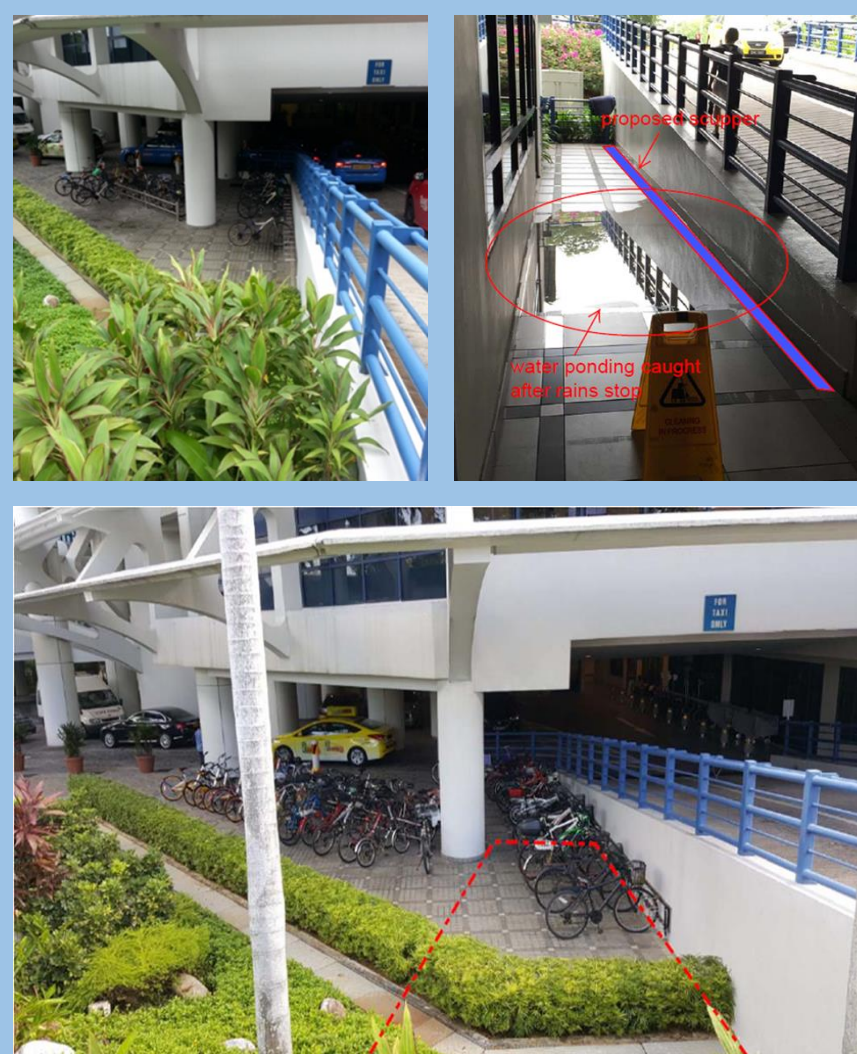
## 3. Methodology

Decided to build a staircase beside the vehicle ramp and improve drainage at the base of the proposed staircase and along the footpath.

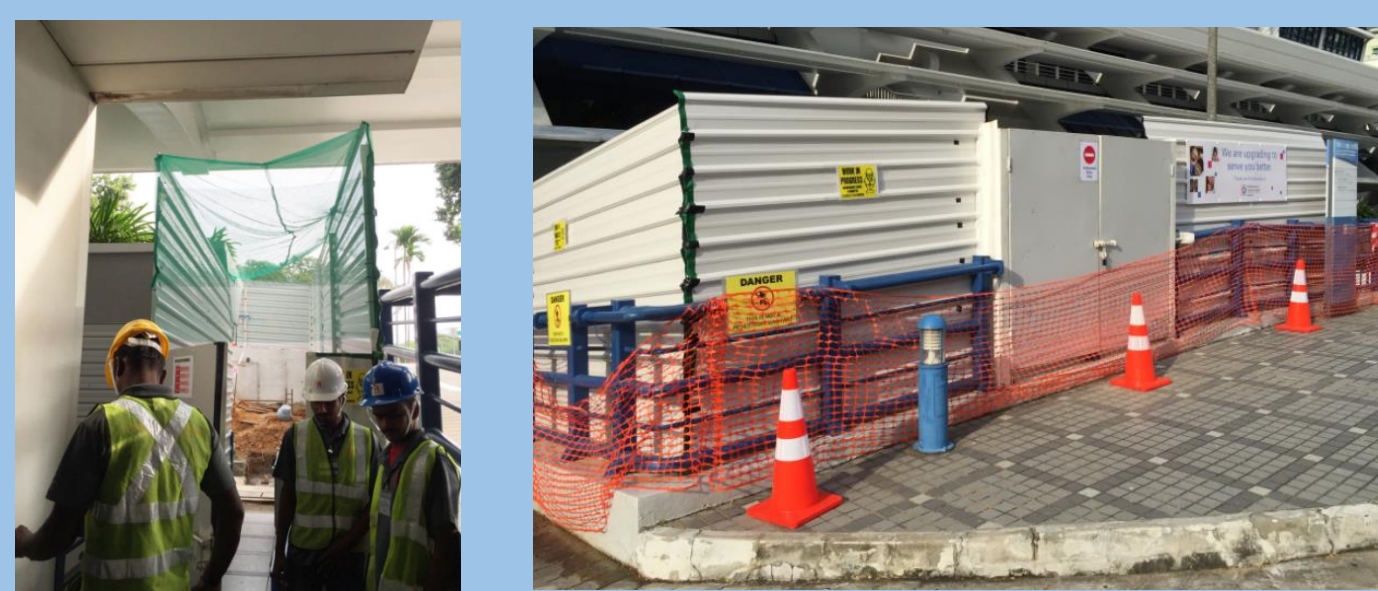
### 3b. Do

Implemented strict infection and noise control measures to safeguard well-being of occupants in adjacent clinics and nearby wards, plus operations of the nearby KKIVF Lab.

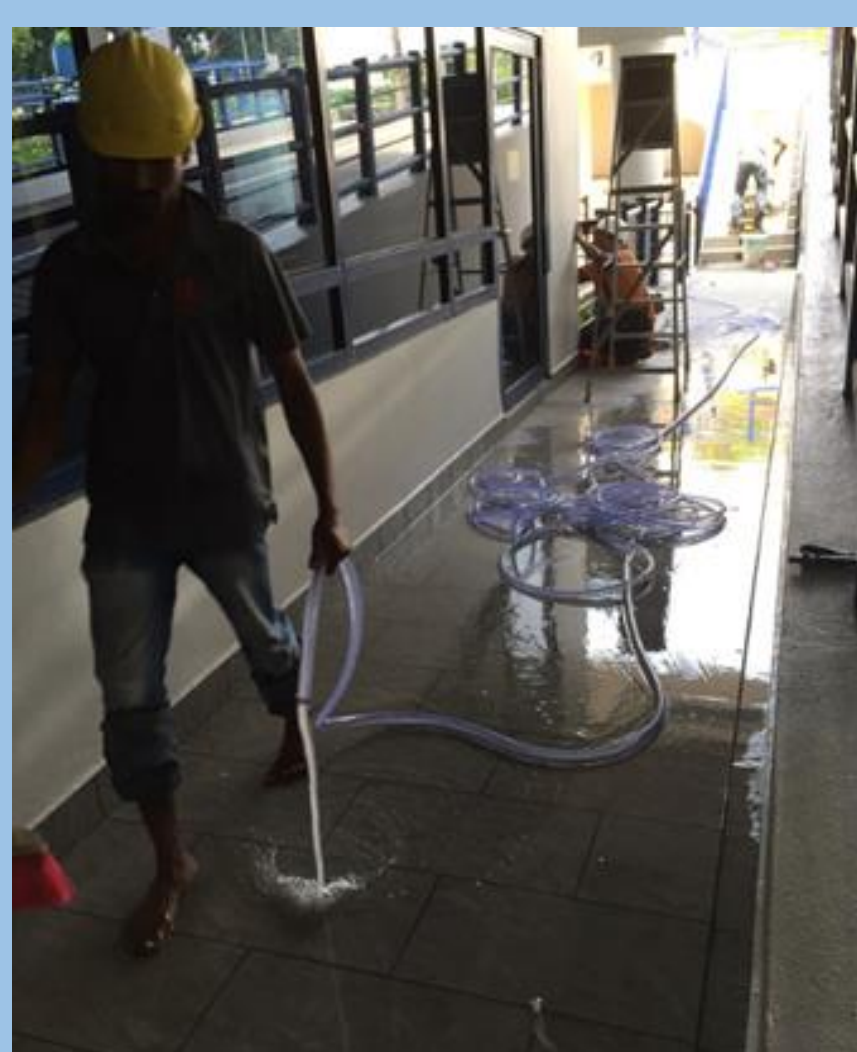
### 3c. Check

Assessed anti-slip tiles and tested drainage provisions to ensure rapid drain off even during prolonged, heavy rain.

Assessed various designs for signage to advise pedestrians to use the new staircase and avoid using the vehicle ramp.

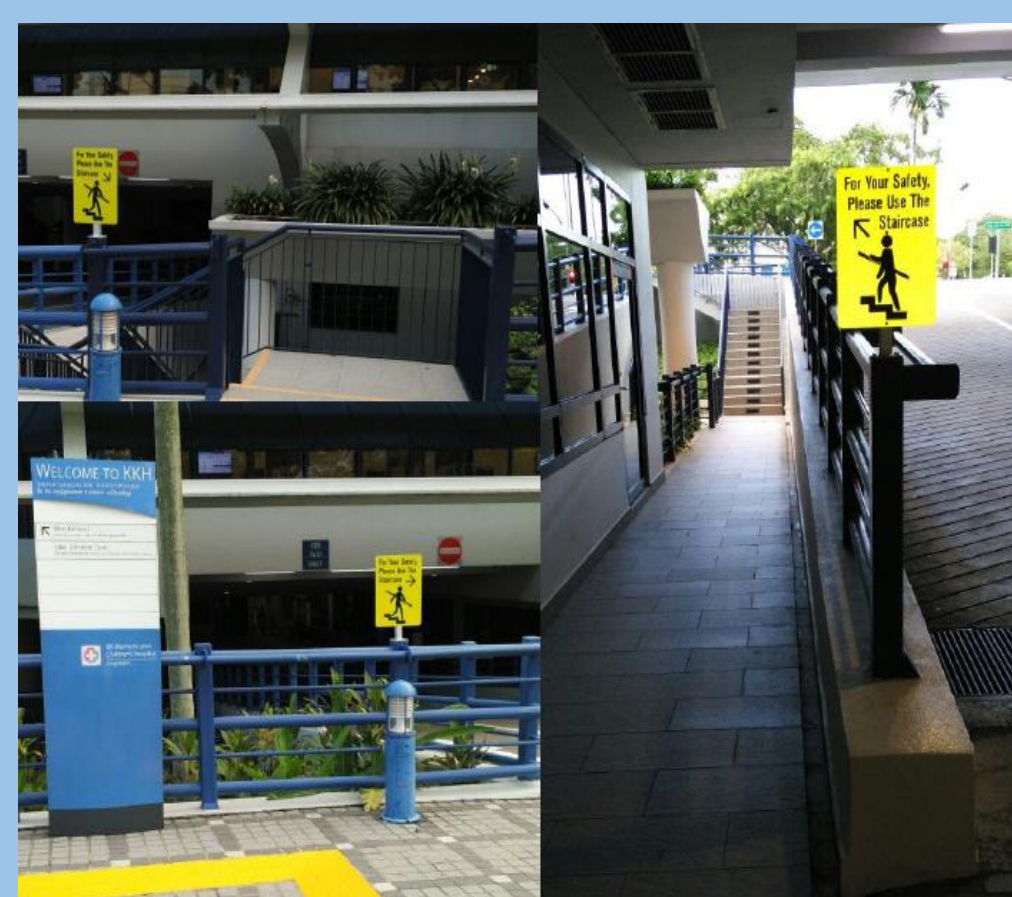
### 3d. Action

Installed clear, eye-catching signage at street level and basement 1 to alert and advise pedestrians to use the new staircase.

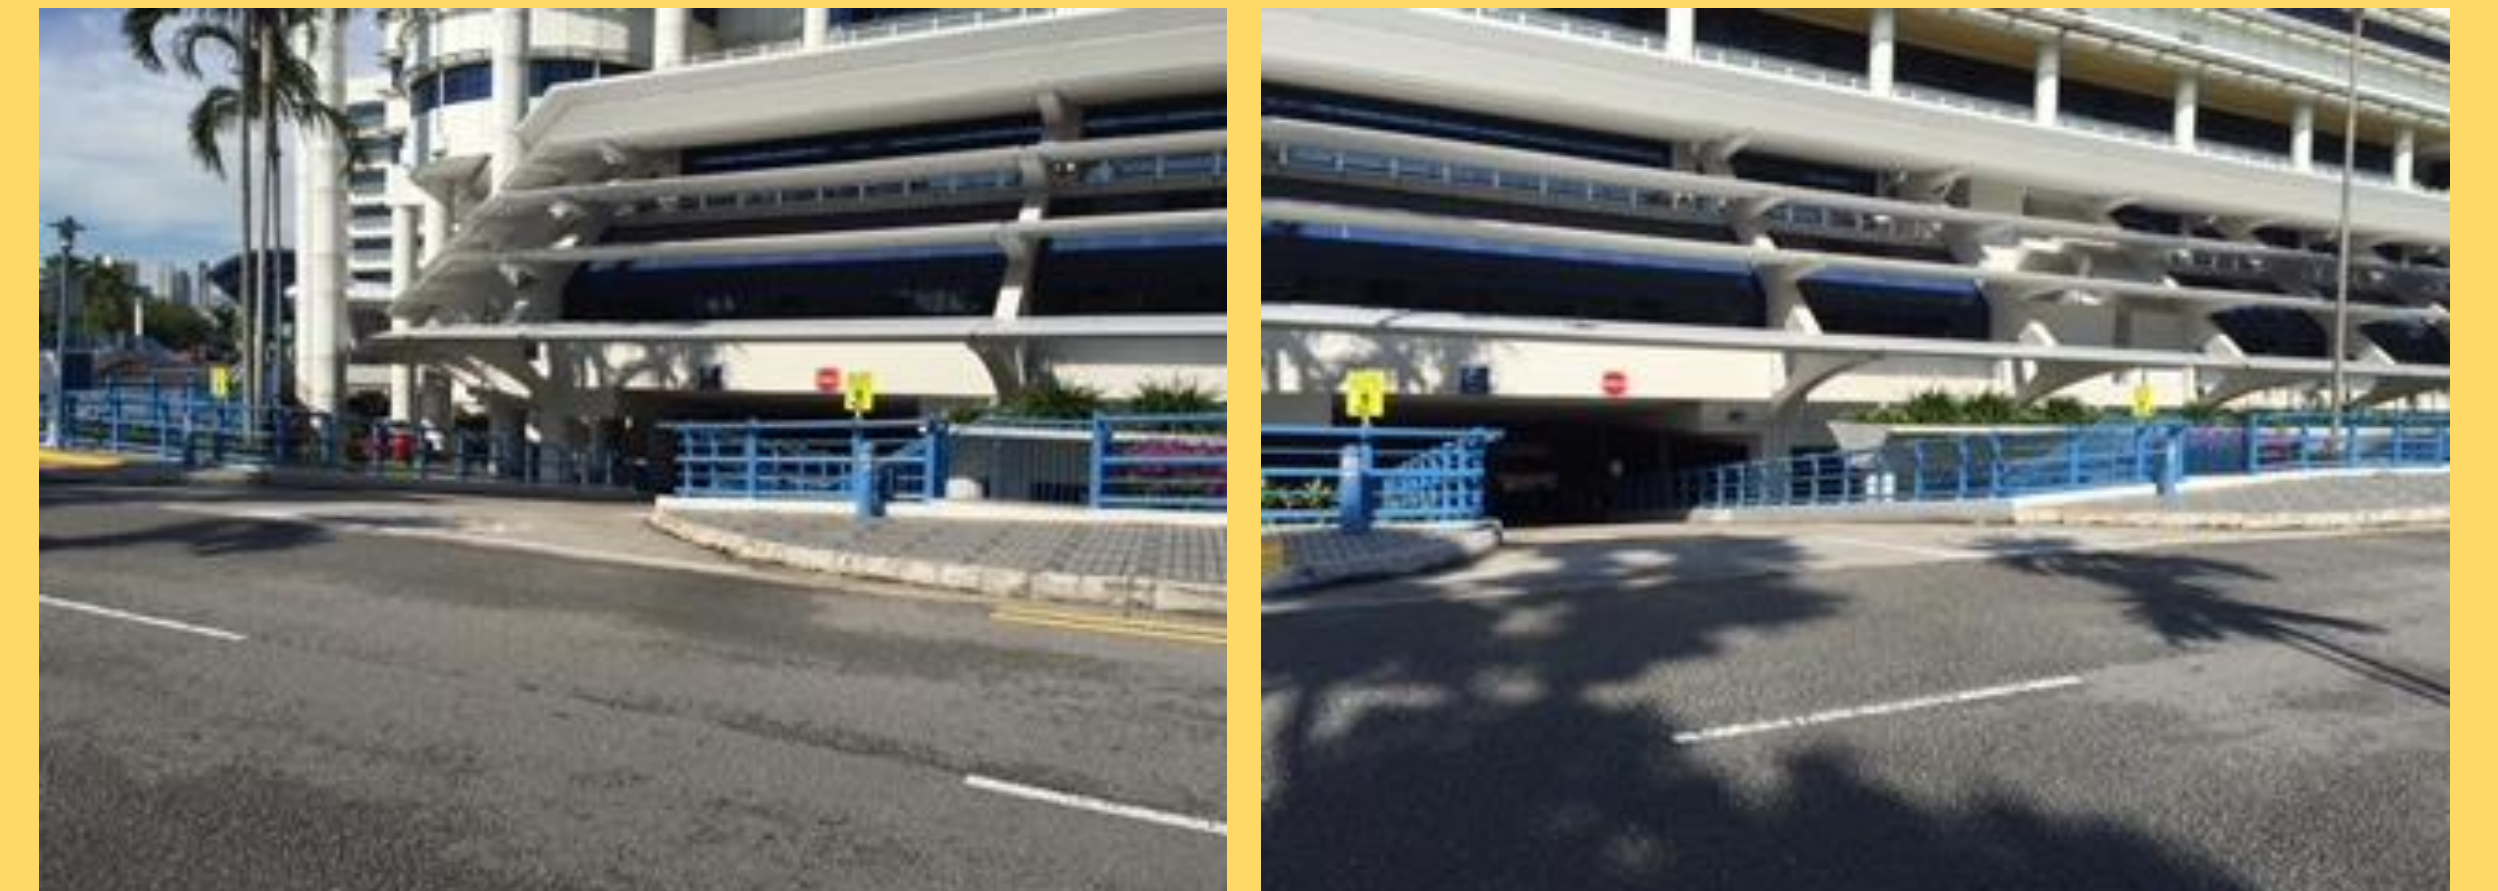
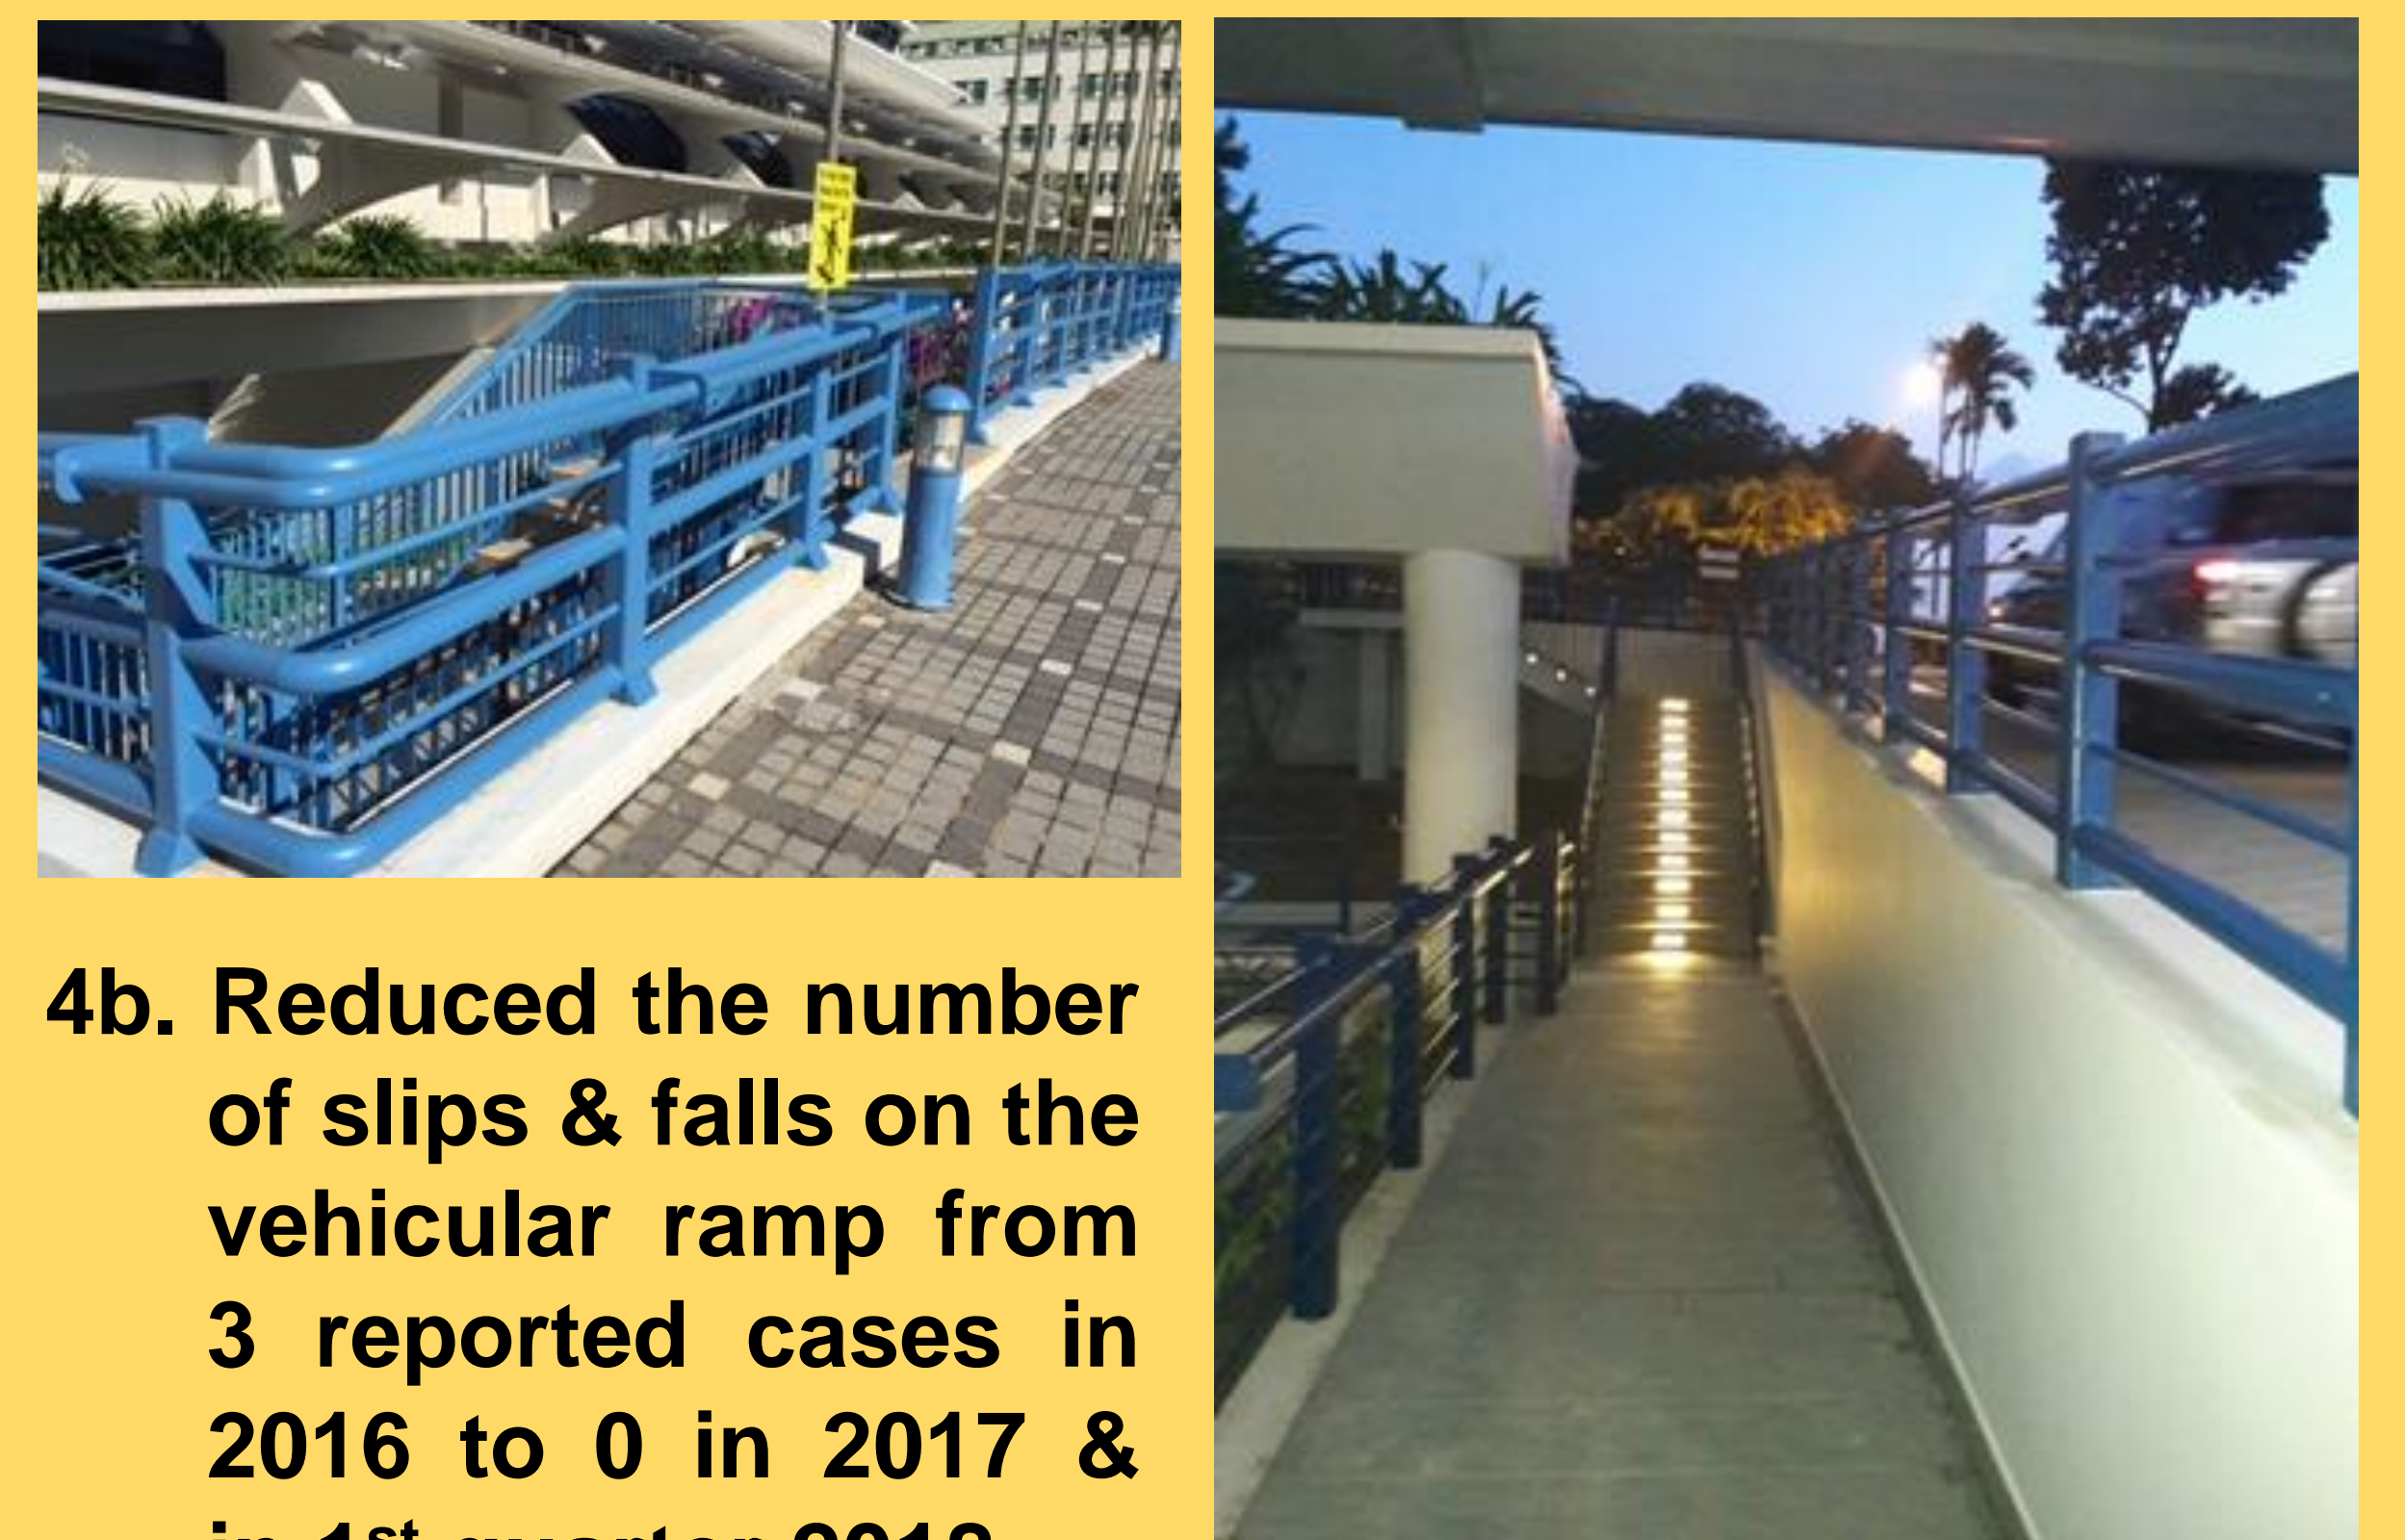
4a. Provided pedestrians with a direct, well-lit, anti-slip staircase linking street level & basement 1 at the entrance of Women's Tower.

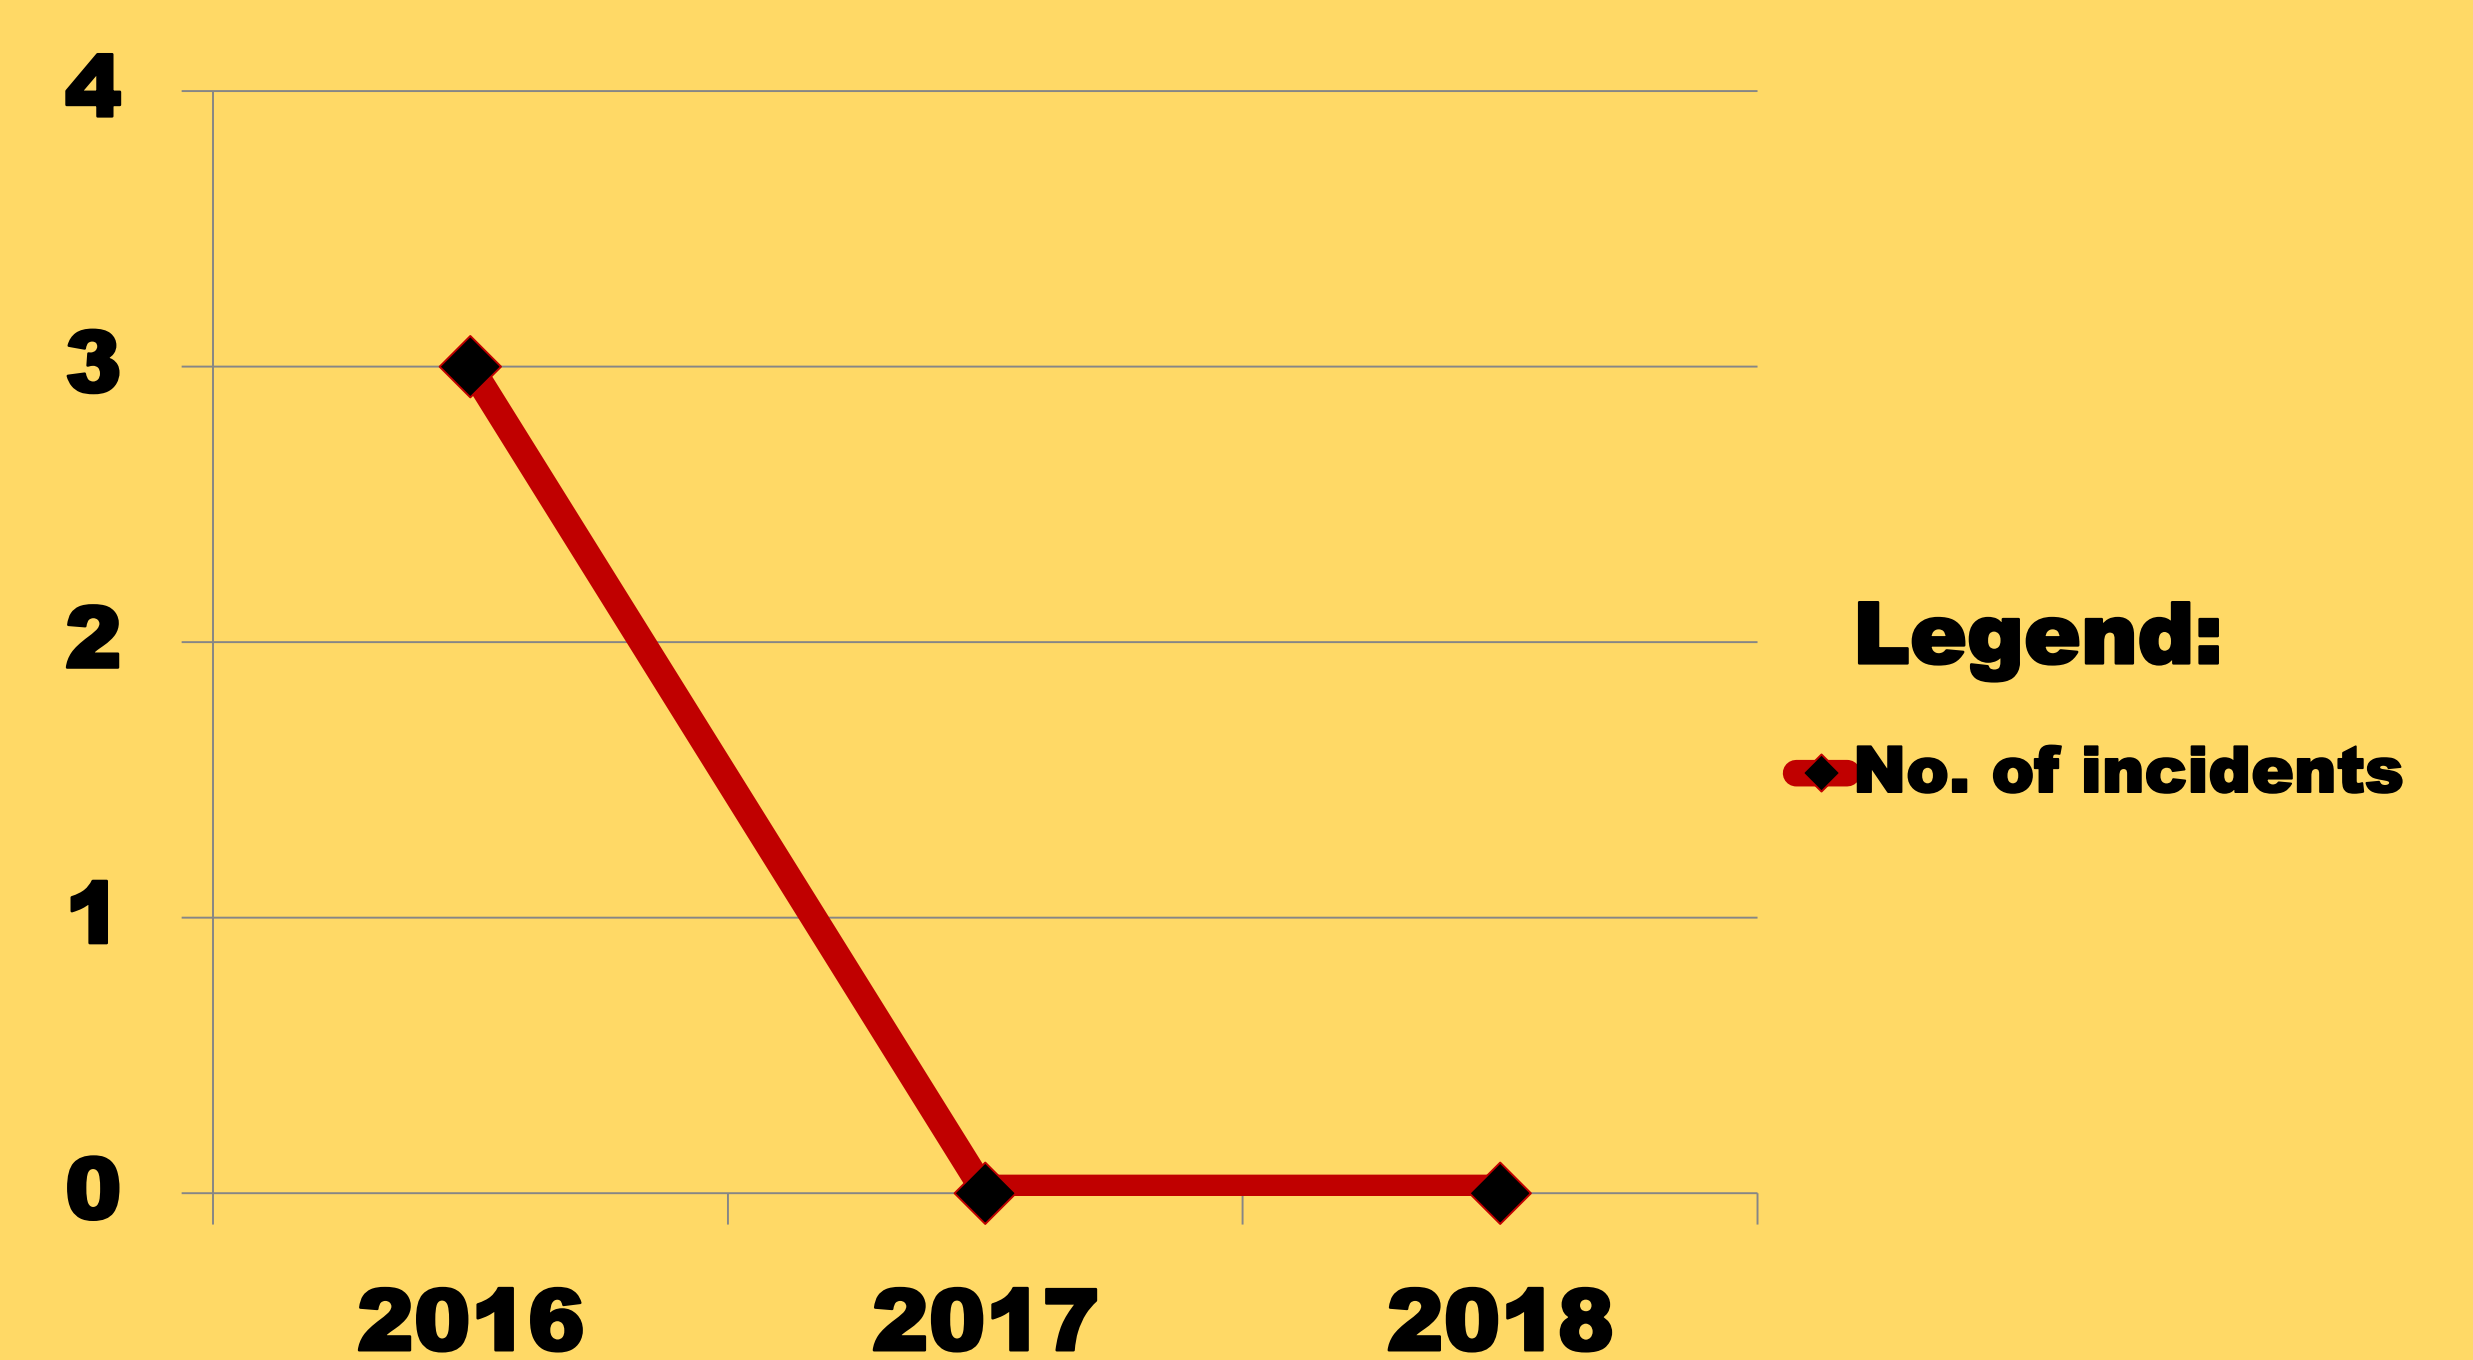
4b. Reduced the number of slips & falls on the vehicular ramp from 3 reported cases in 2016 to 0 in 2017 & in 1st quarter 2018.

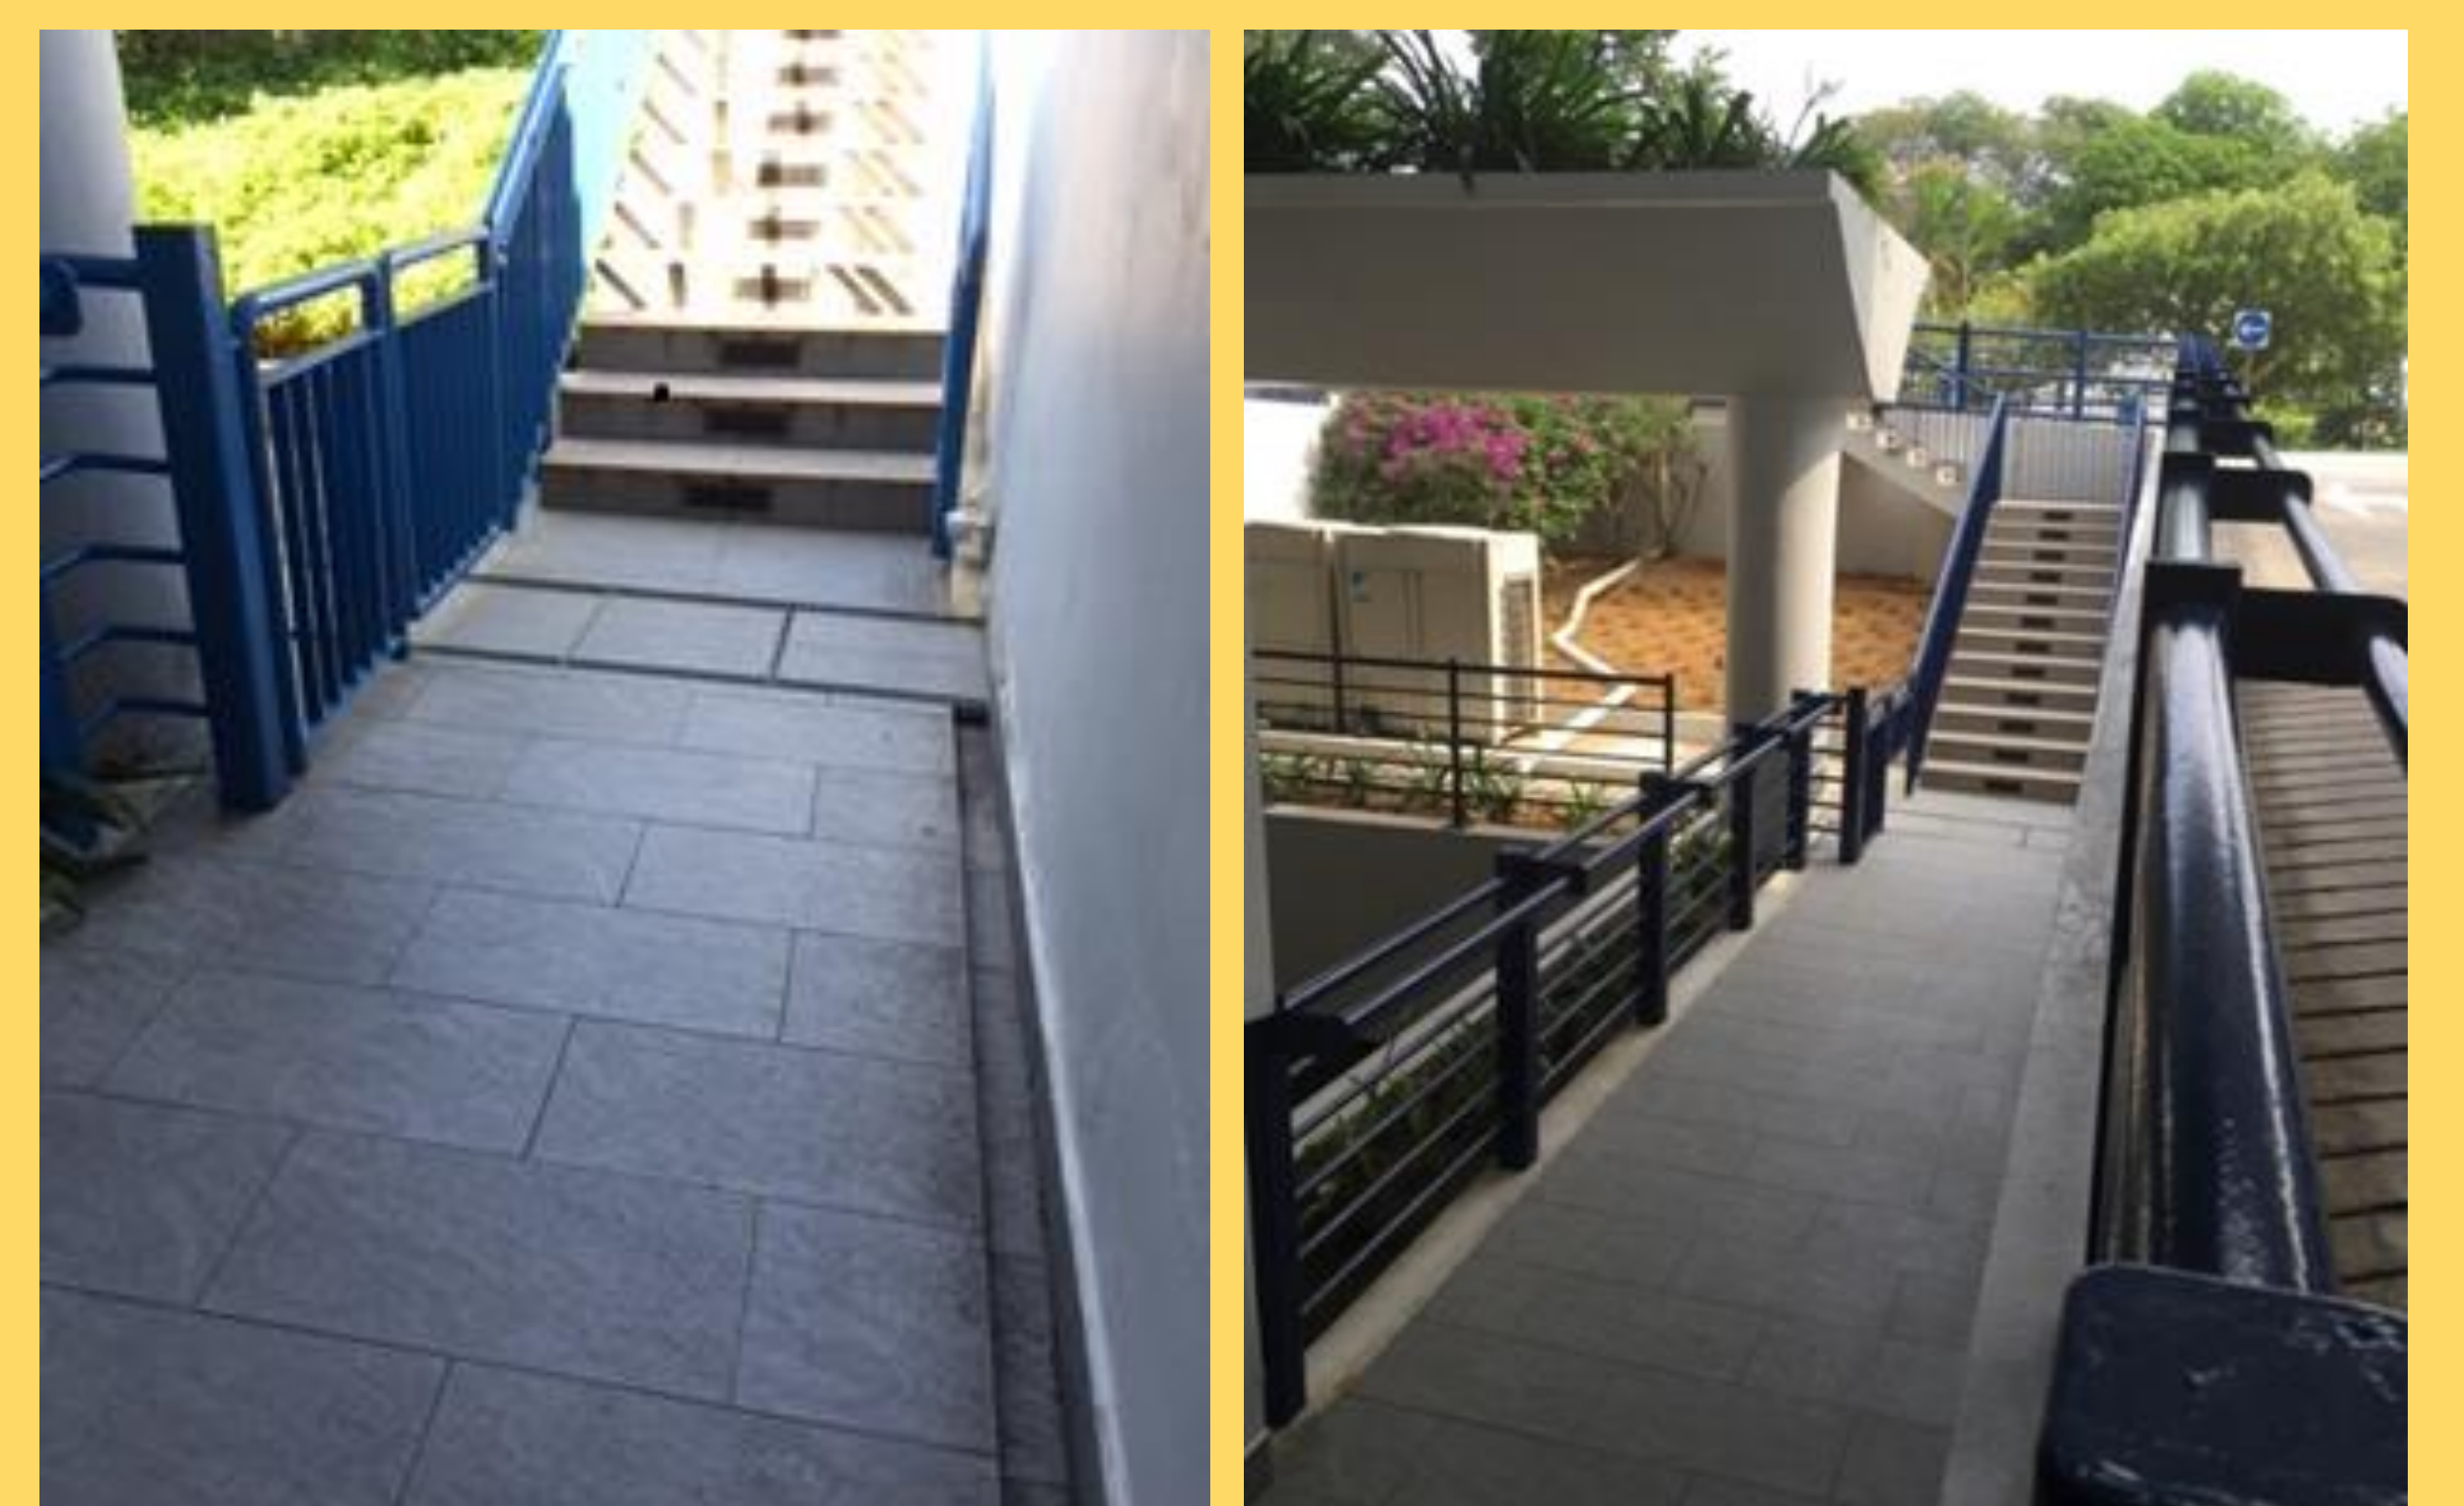
4c. Improved drainage along the footpath beside the ramp to eliminate potential slips & falls due to water-ponding. Resurfaced the footpath with anti-slip tiles to improve pedestrian safety during wet weather.
