Eliminate Hazard on Use of the Calf Compression Unit

Eliminate hazard on use of the calf compression unit

AIM: Eliminate hazard on broken earth pin of the power plug of the calf compression unit

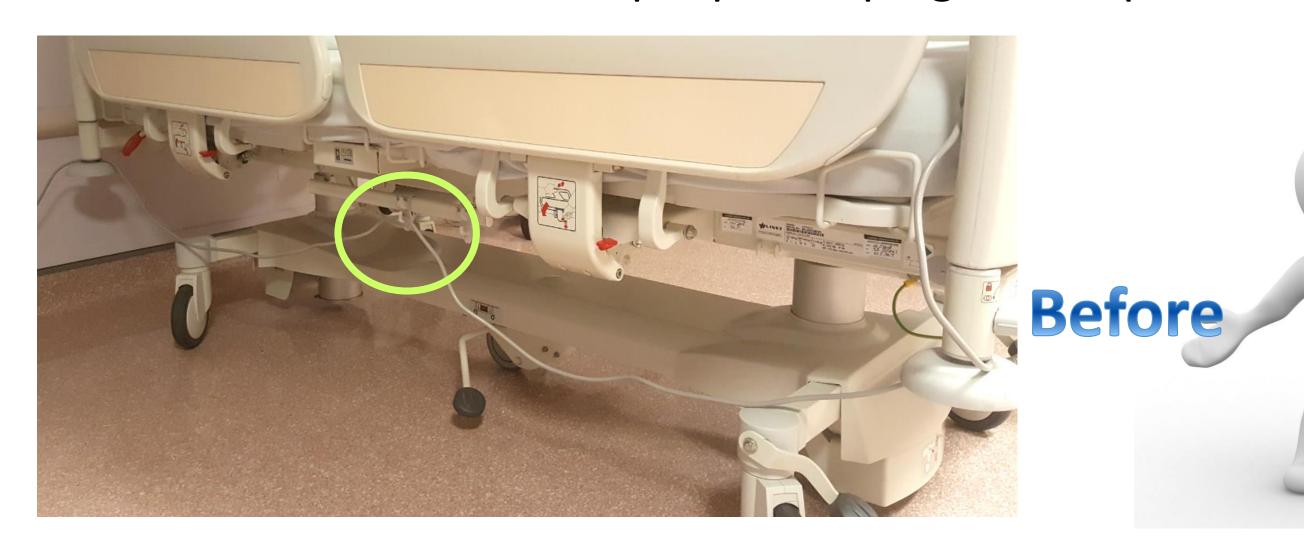
There was no broken earth pin power plug fault reported after implementing the use of Carabiner Snap Hook.

Using the Carabiner Snap Hooks eliminated the hazard of broken earth pin of the power plug of the calf compression unit. We will change to the Carabiner S Style Snap Clip Hook when there is a significant price reduction.
