Improving Safety Around Emergency Department (ED) Ambulance Bay

Ng Teng Fong General Hospital

IMPROVING SAFETY AROUND ED AMBULANCE BAY

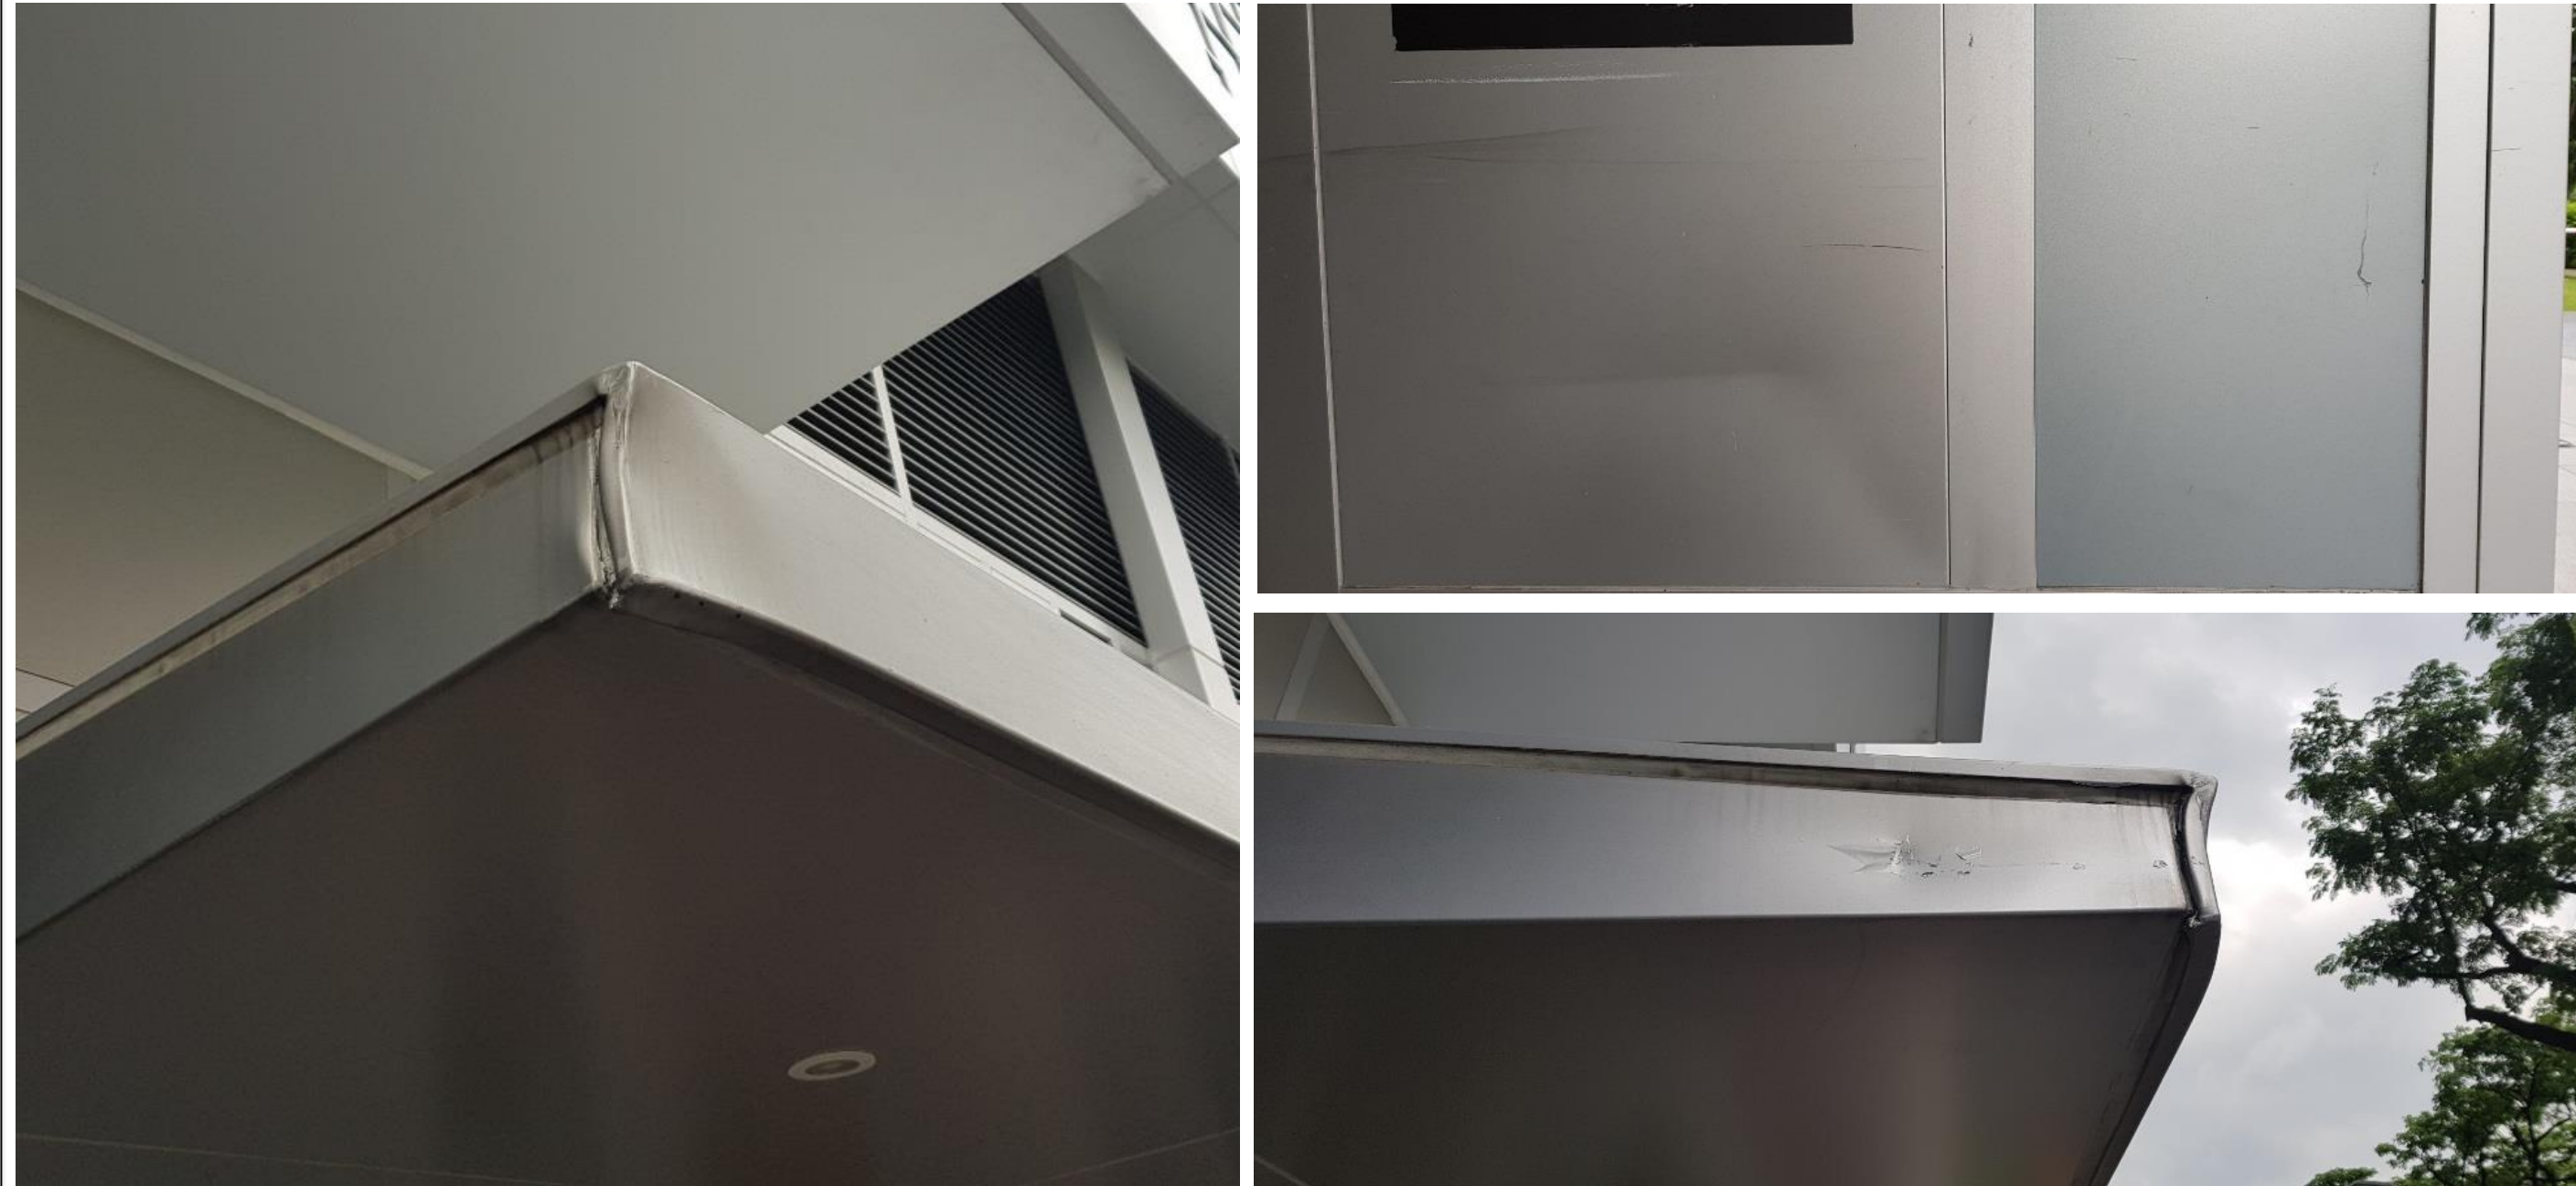
The visitor walkway linking ED's P3 service area and the Emergency Visitor Lounge passes by the ambulance bay. There are scratches on the walls and rooftop of this walkway, a result of near misses by inexperienced ambulance operators.

1. Multiple points of damage by ambulances very near walkway between ED P3 service area and Emergency Visitor Lounge.

1. Reflective bollards, cordons & cautionary floor prints, to improve visibility of pavement to vehicles and keep visitors on path.

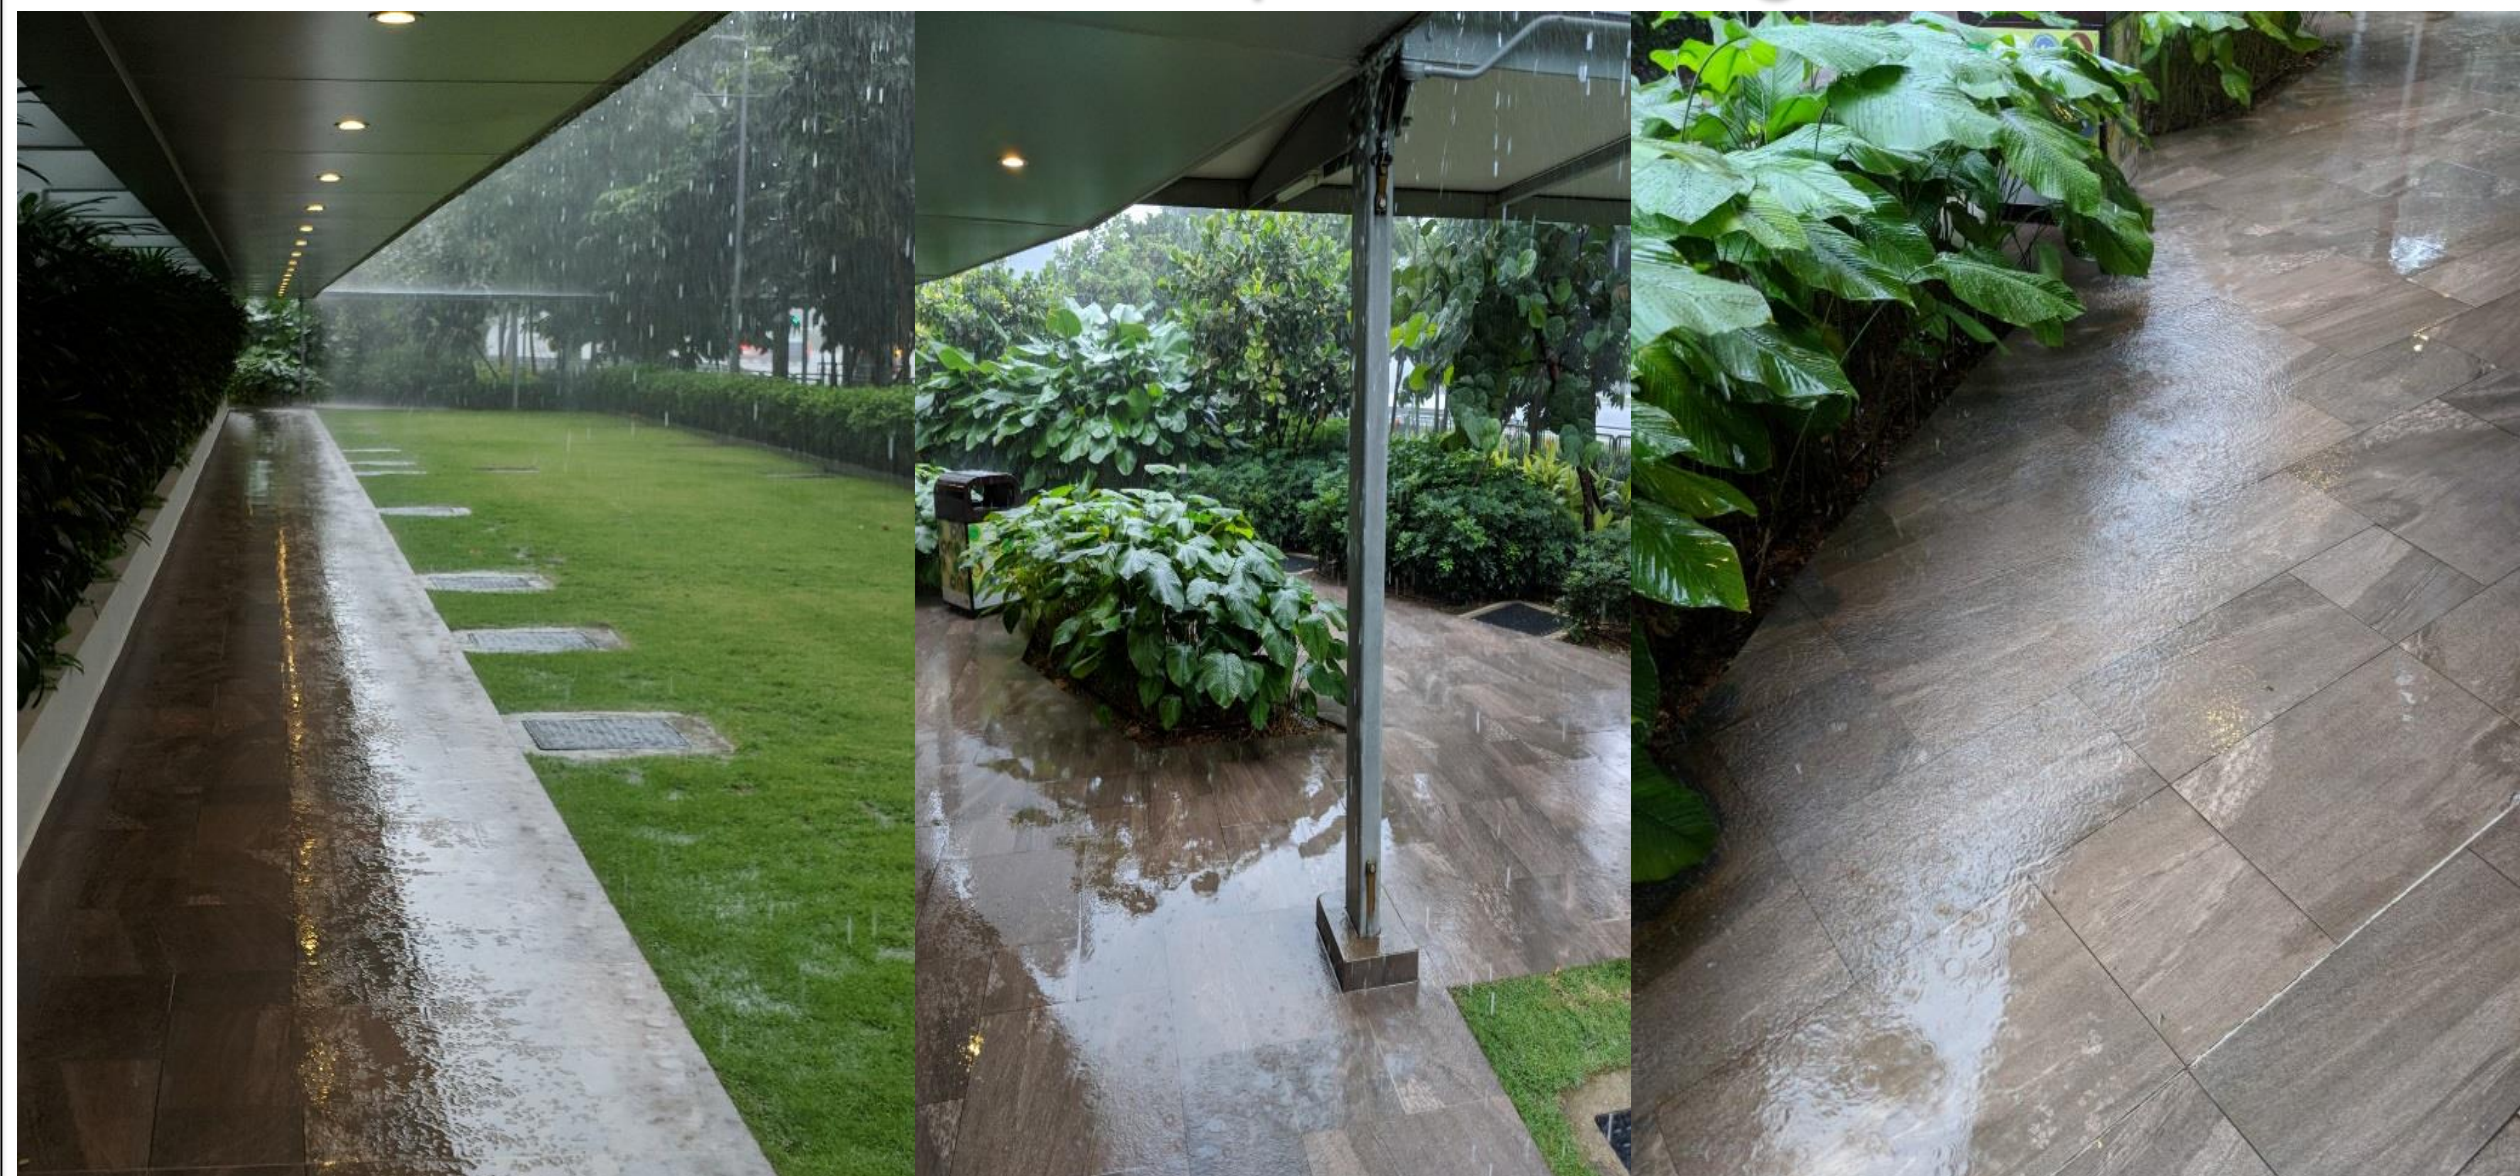
3. When there is rain, the pavement between the two service points becomes a fall hazard as water pools on the ground.

2. Change out planter so rain-water may discharge properly without pooling and increasing fall risk.

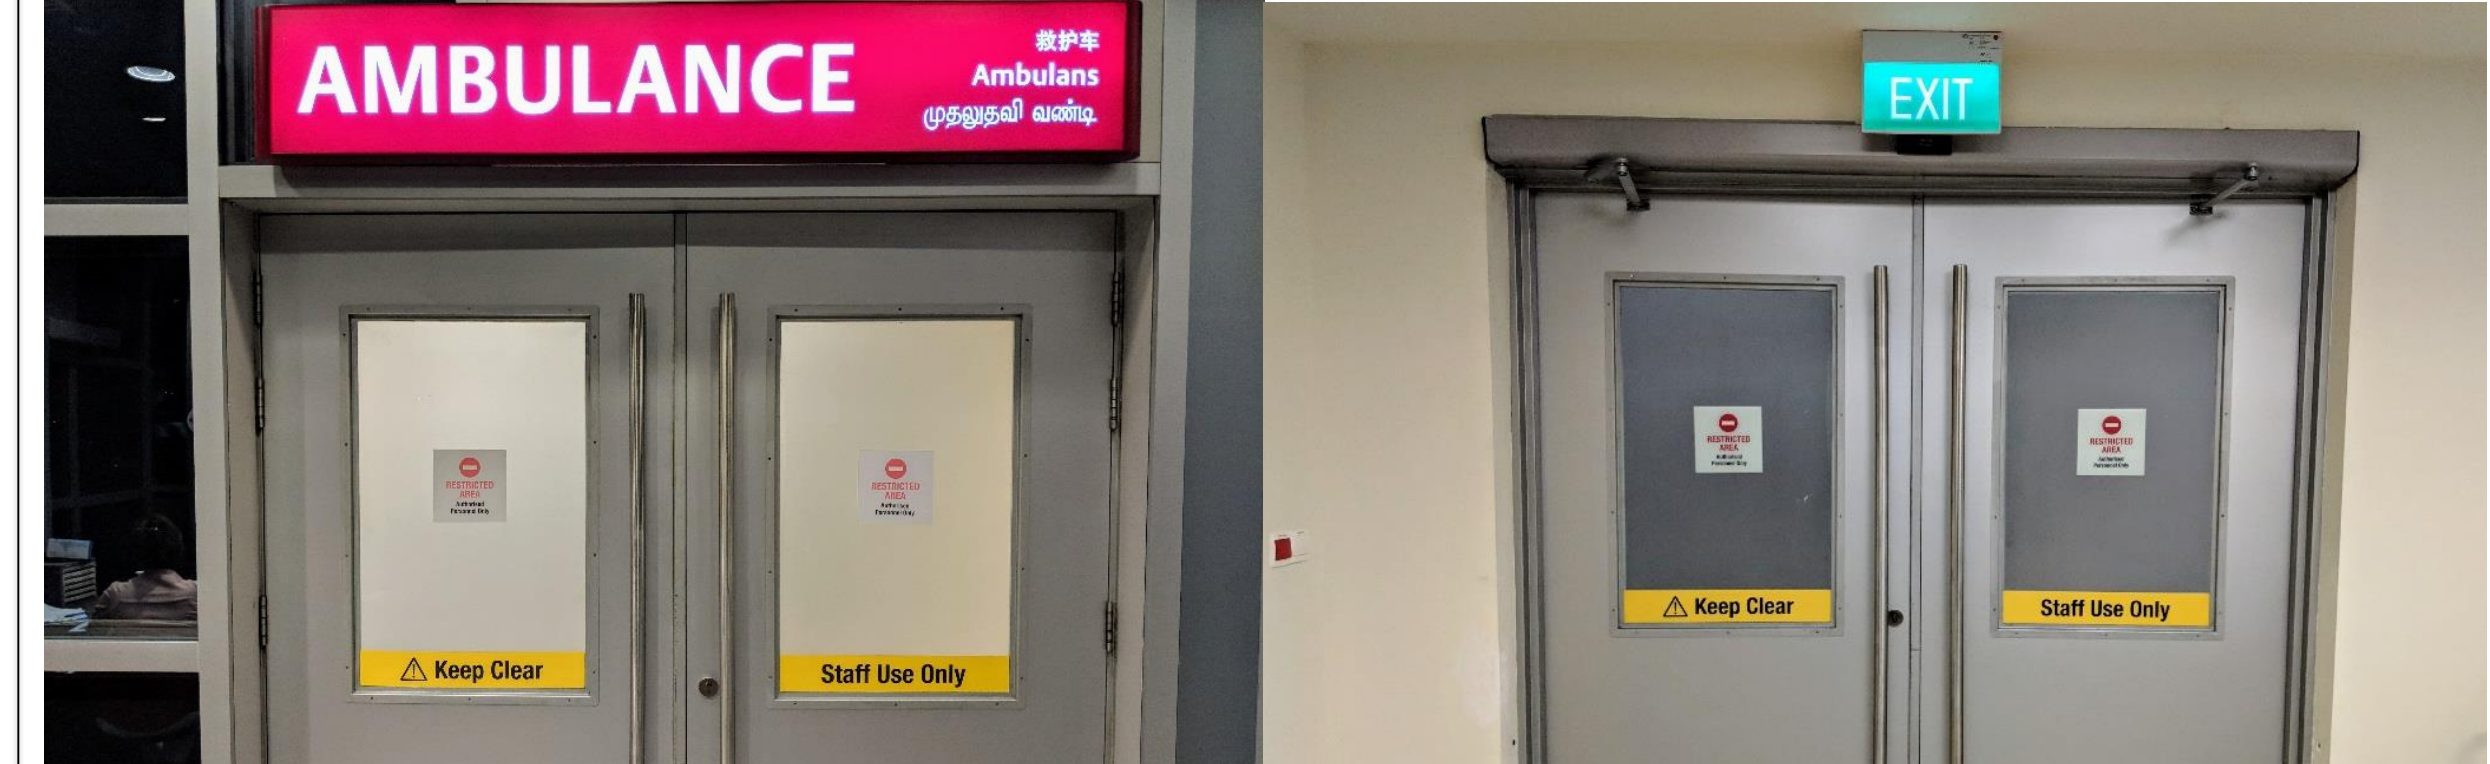
3. Bright yellow cautionary strips and additional restricted entry stickers to keep visitors clear of ambulance access swing doors.

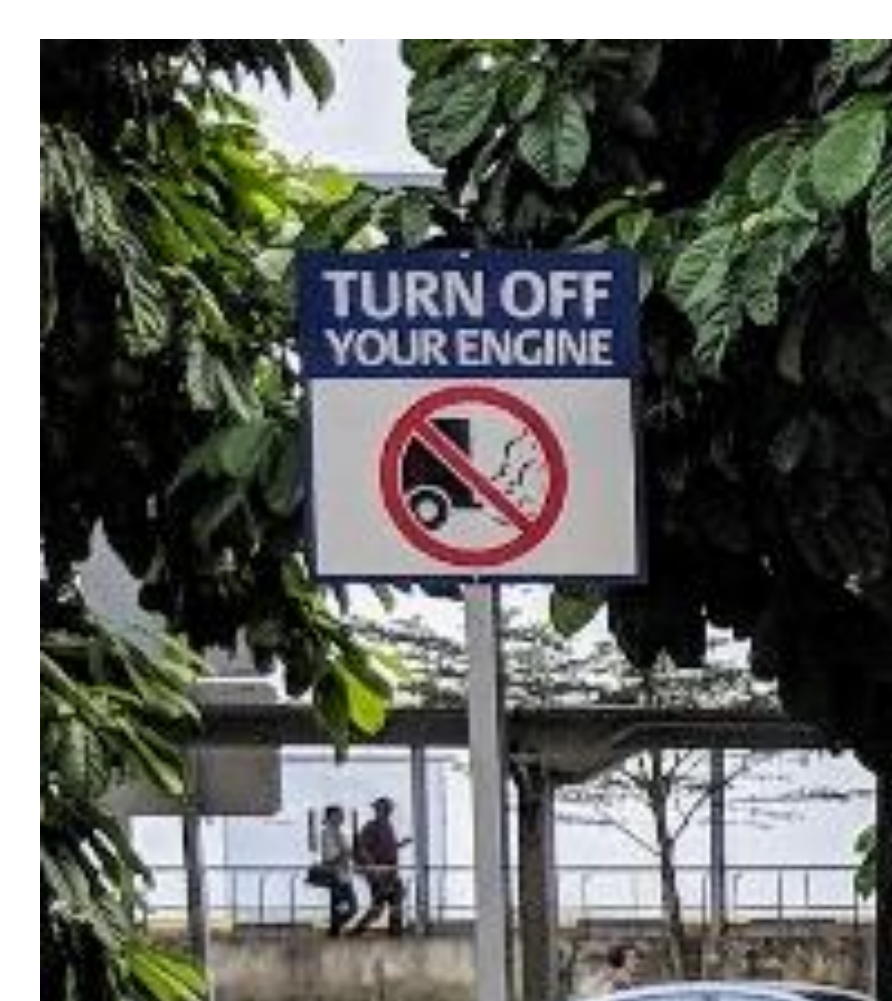
5. Signs reminding ambulances to turn off idling engines.
